2 Murray Road
(Central)
中環美利道2號

20240525 HKIE Technical Visit (BUD) The Henderson

1. Project Profile

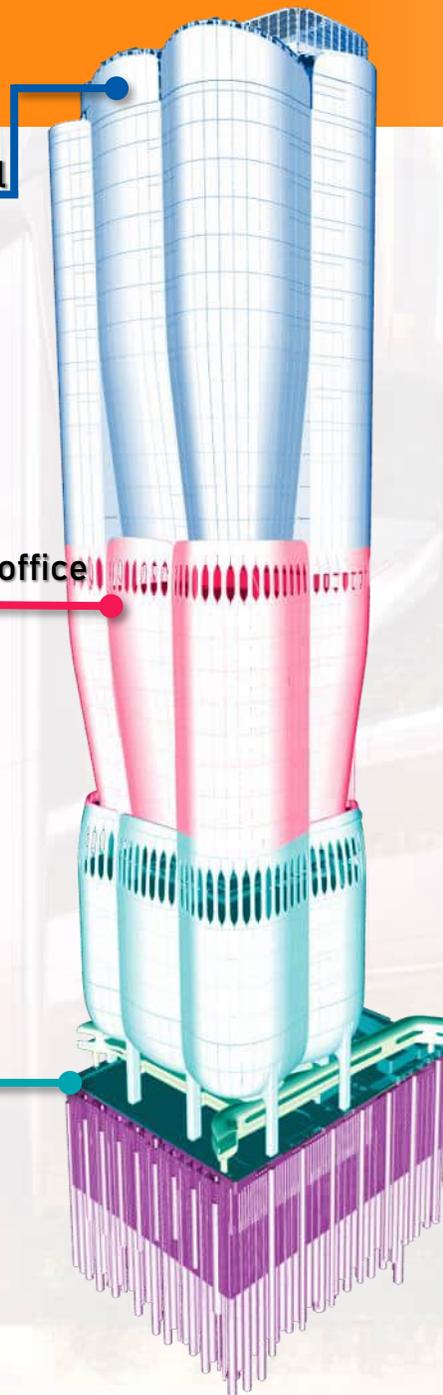
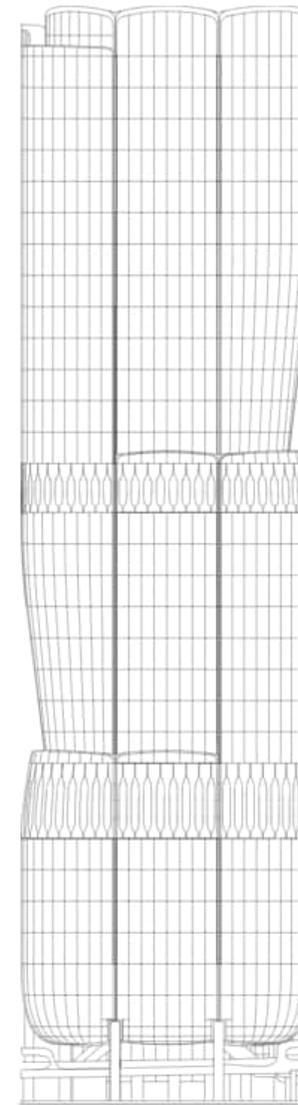
Rooftop Banquet Hall	39/F
High Zone	26/F - 38/F
Sky Garden	22/F
Low Zone	6/F - 25/F
Restaurant	5/F
Lobby & Coffee Kiosk	3/F
Walkway to MTR	1/F
Lobby & VIP Drop Off	G/F
Loading / Unloading	B1
Car Park	B2
🚗 265 (with EV Chargers)	B3
🚲 78	B4
	B5

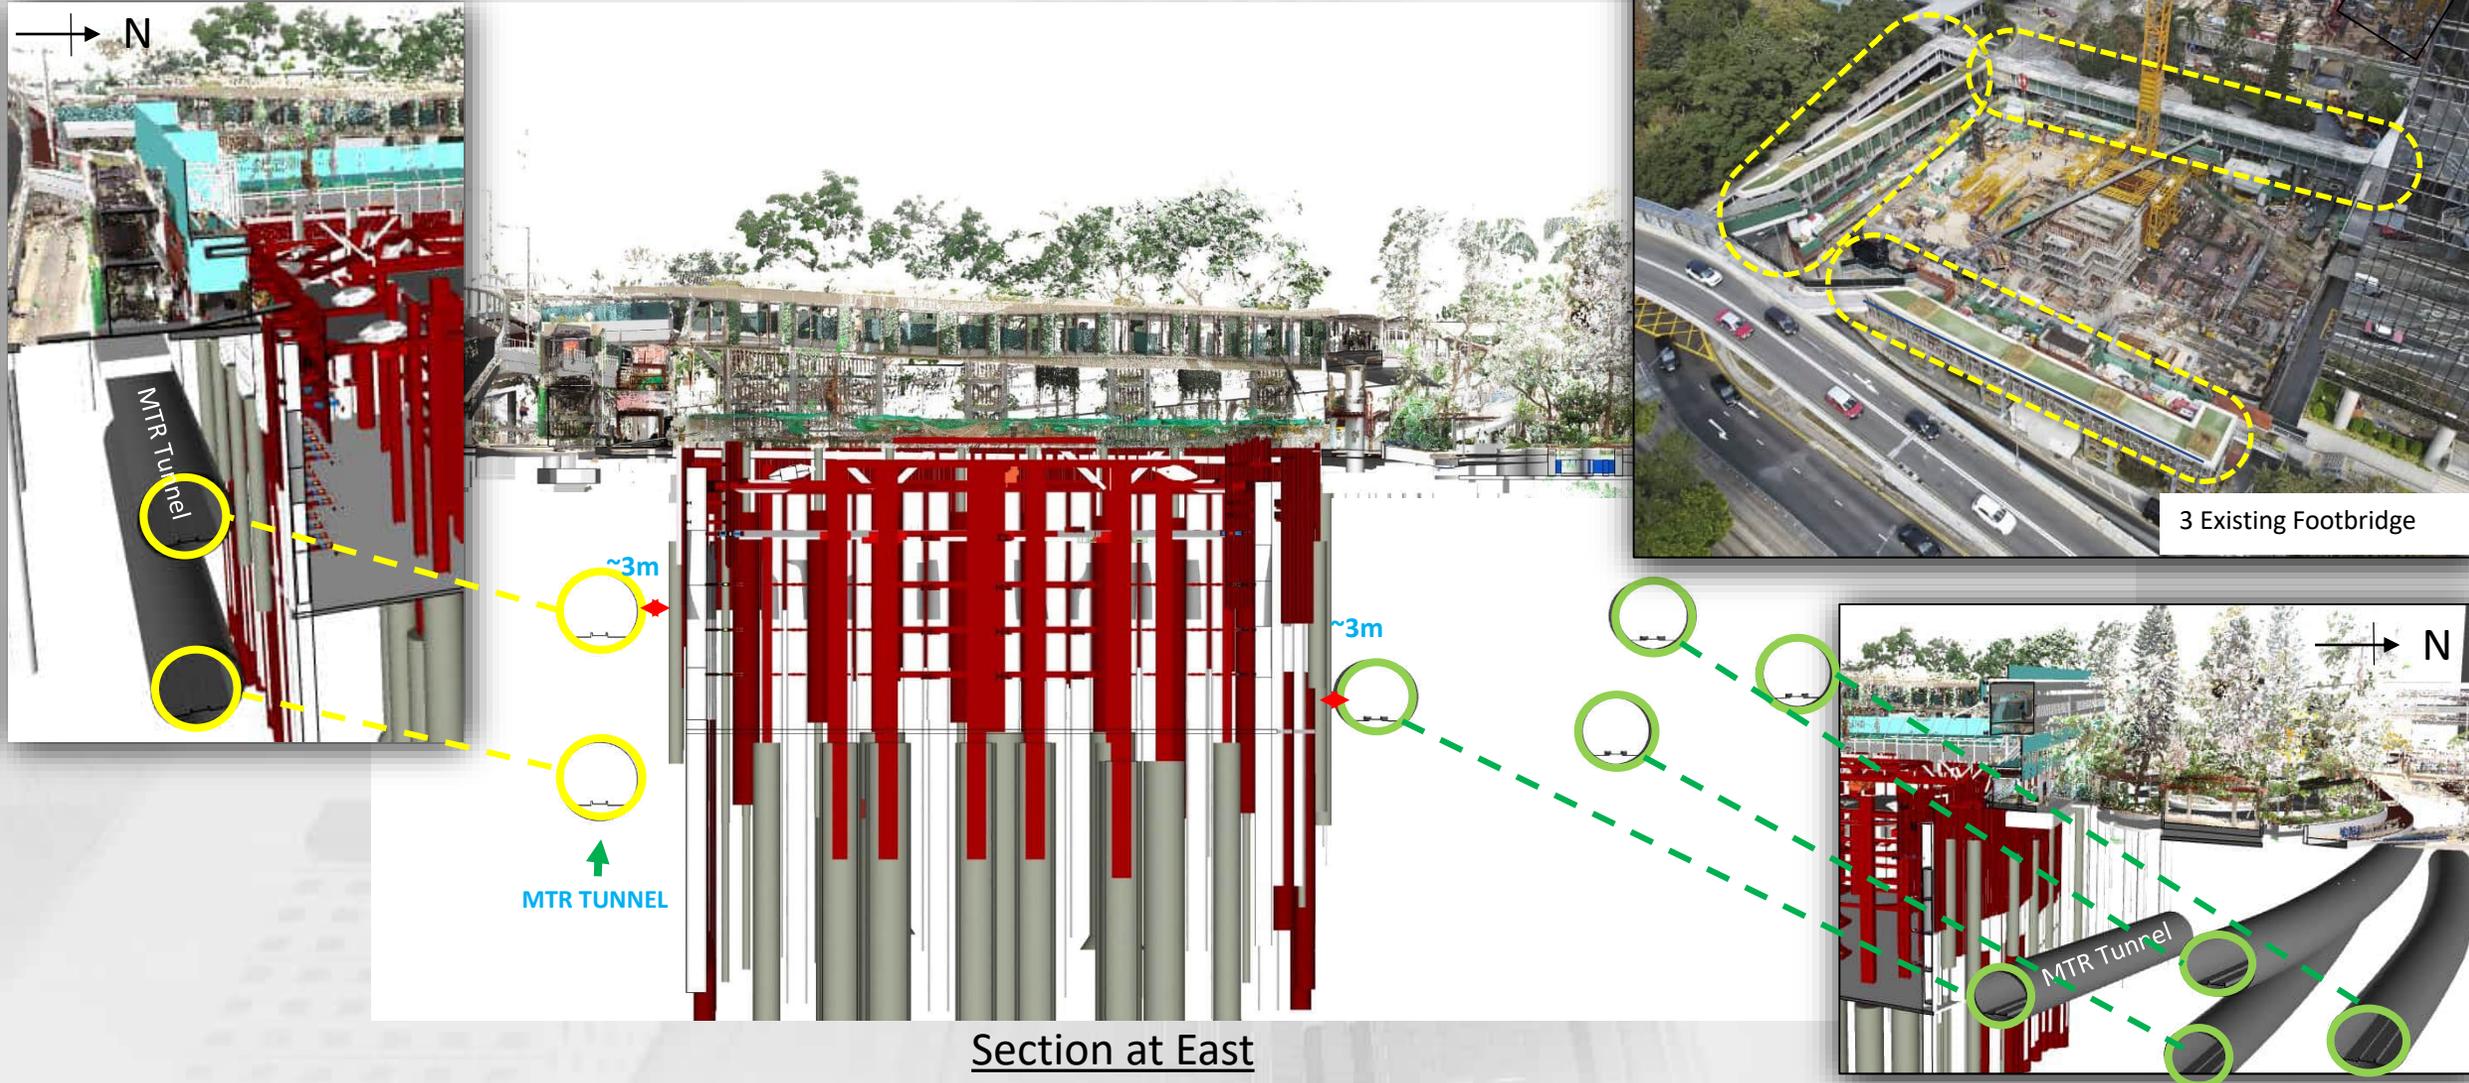
1. The site is enclosed by 6 MTR tunnels and 3 footbridges where sensitive MTR tunnel imposed stringent settlement control

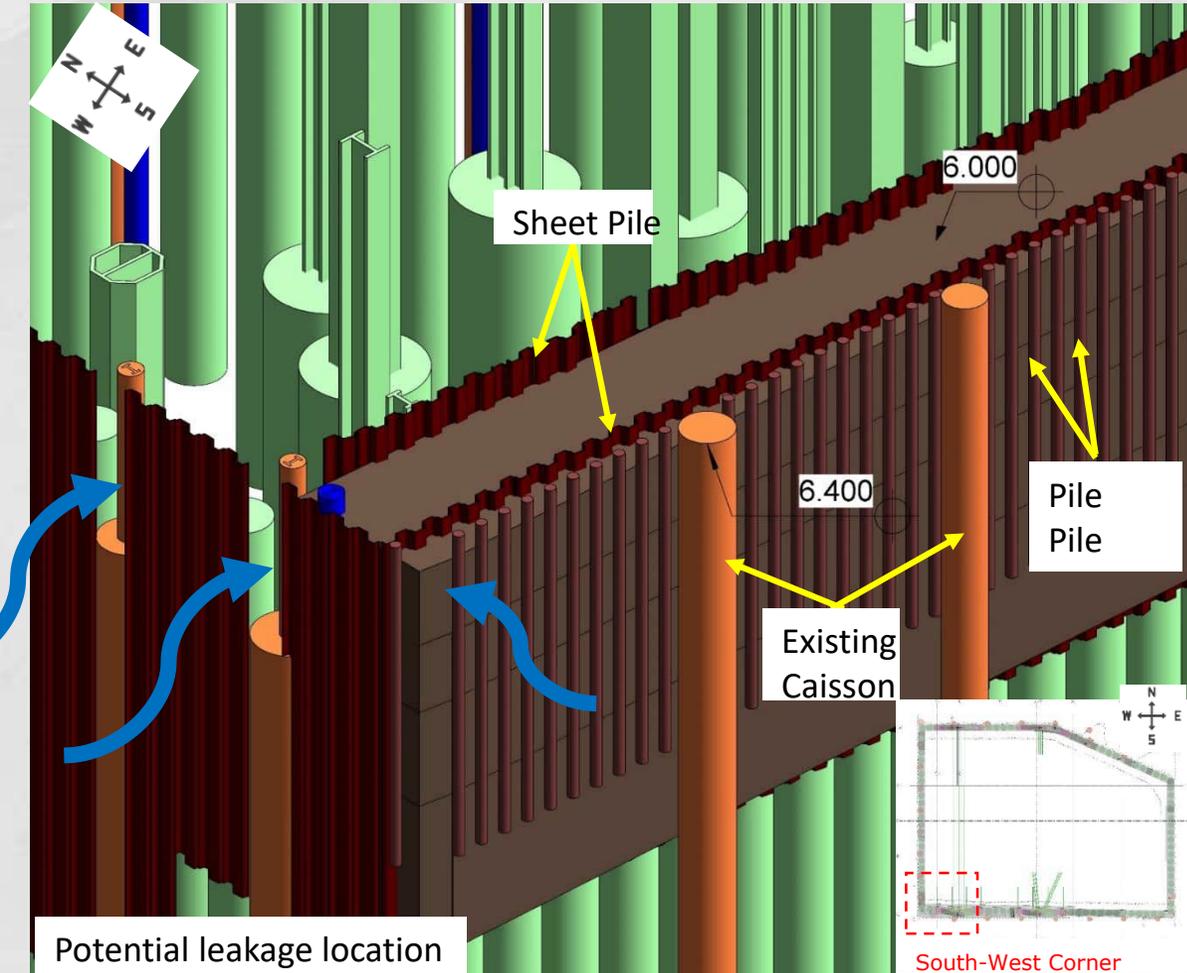
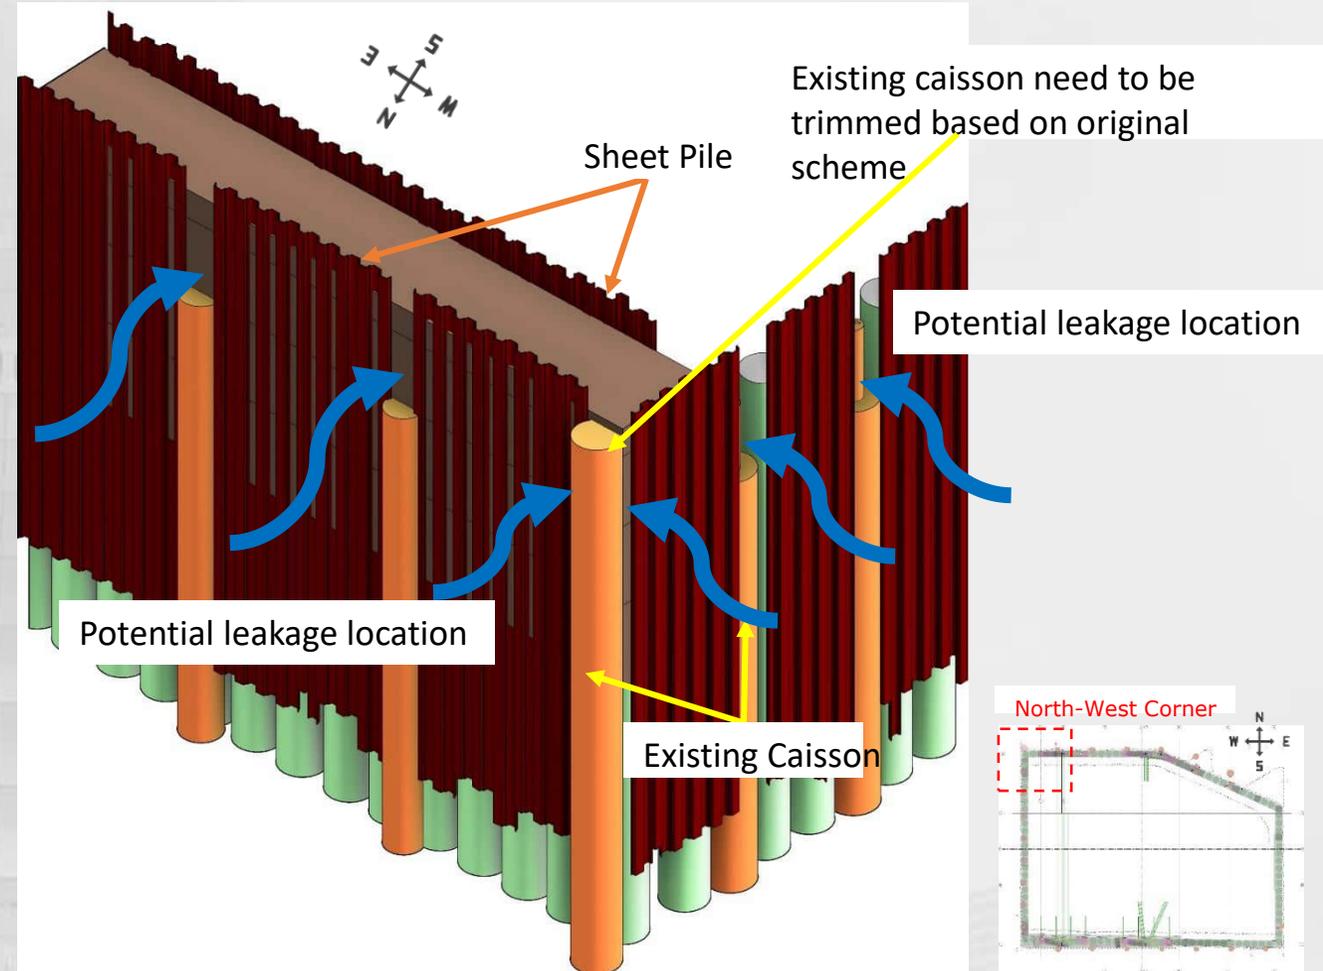
2. Leakage of groundwater & unstable ground during excavation

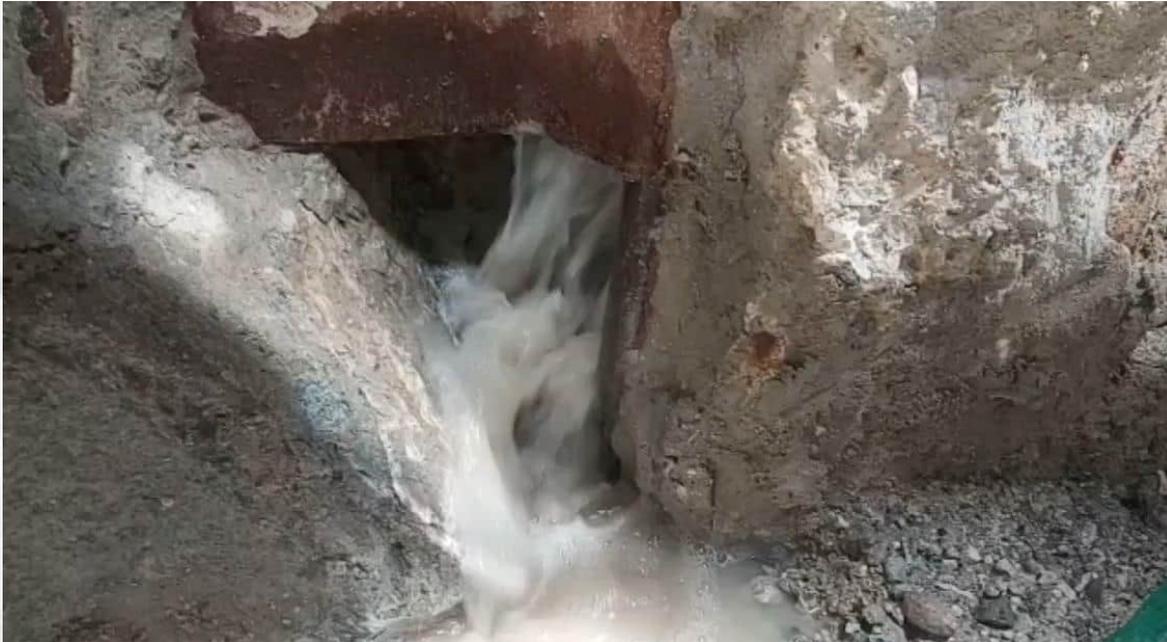
Water Ingression from Sheet pile

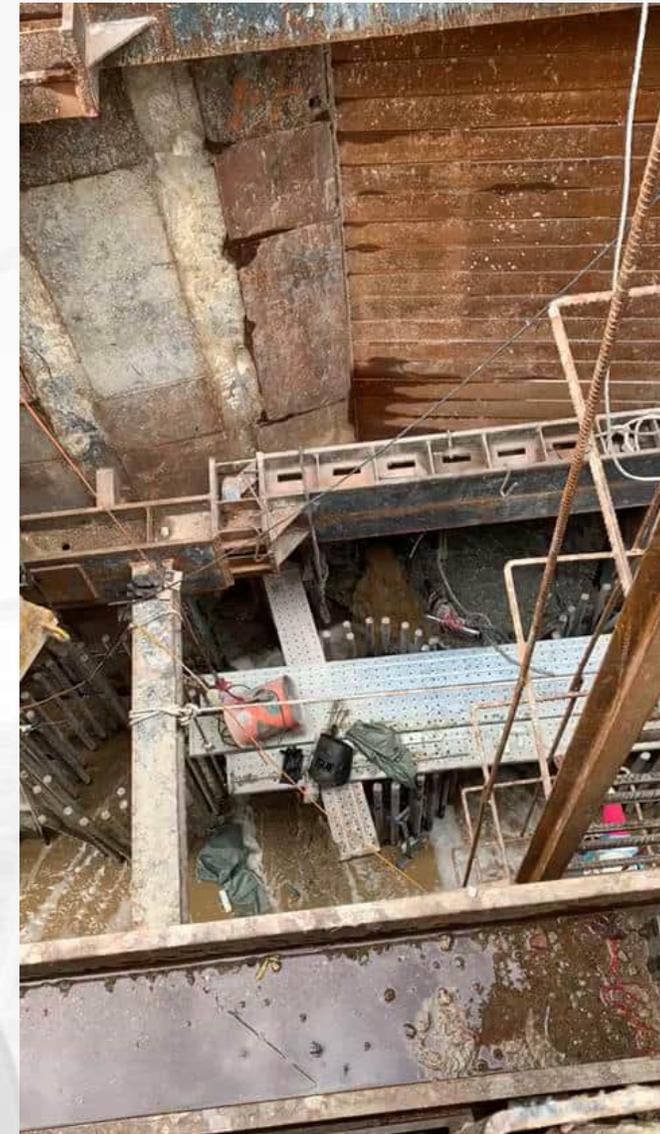
Water Ingression from Sheet Pile

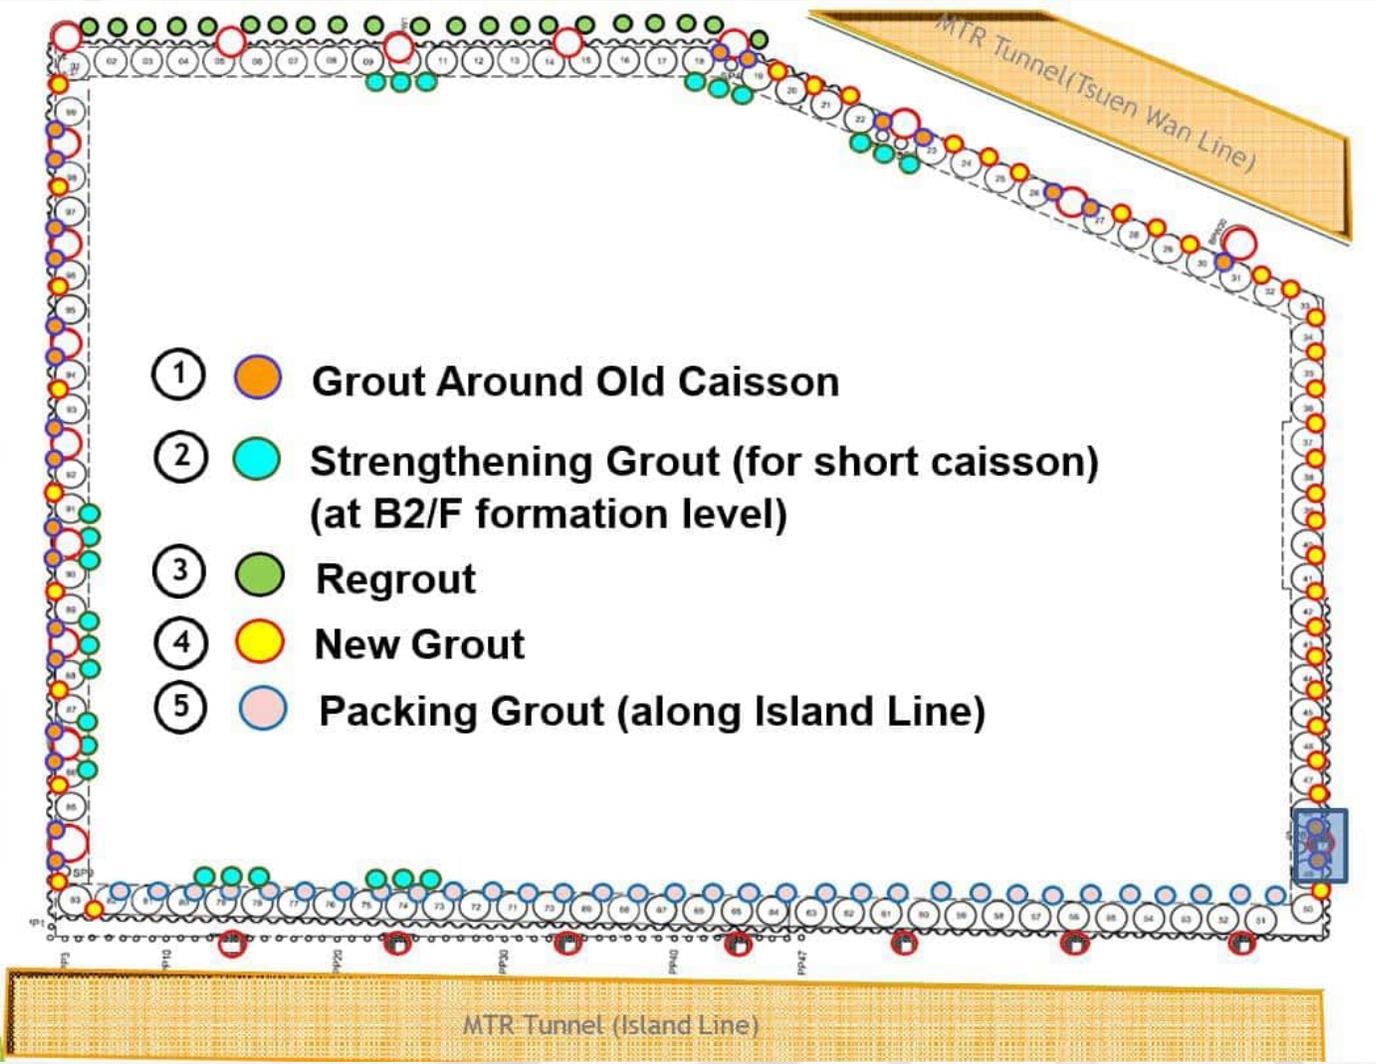
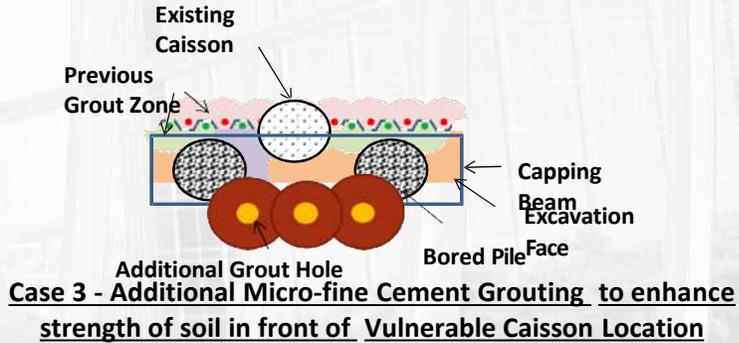
Proactive Preventive Measure for Water Ingression and Tunnel Settlement

Case 3 - Additional Micro-fine Cement Grouting to enhance strength of soil in front of Vulnerable Caisson Location

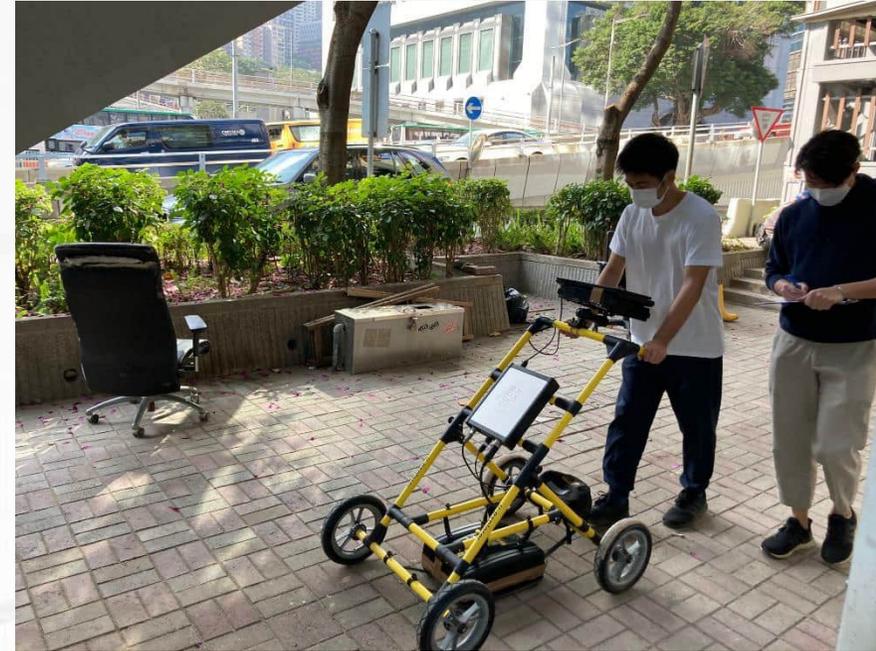
Scan#28

- Regular inspection for underground void by using ground penetrating radar
- After each floor preloading and excavation, ground radar survey will carryout to review the ground situation

Total distance:
48.75m

M: Manhole

○: Signal of
abnormity,
suspected
void or void
inside pipe
duct

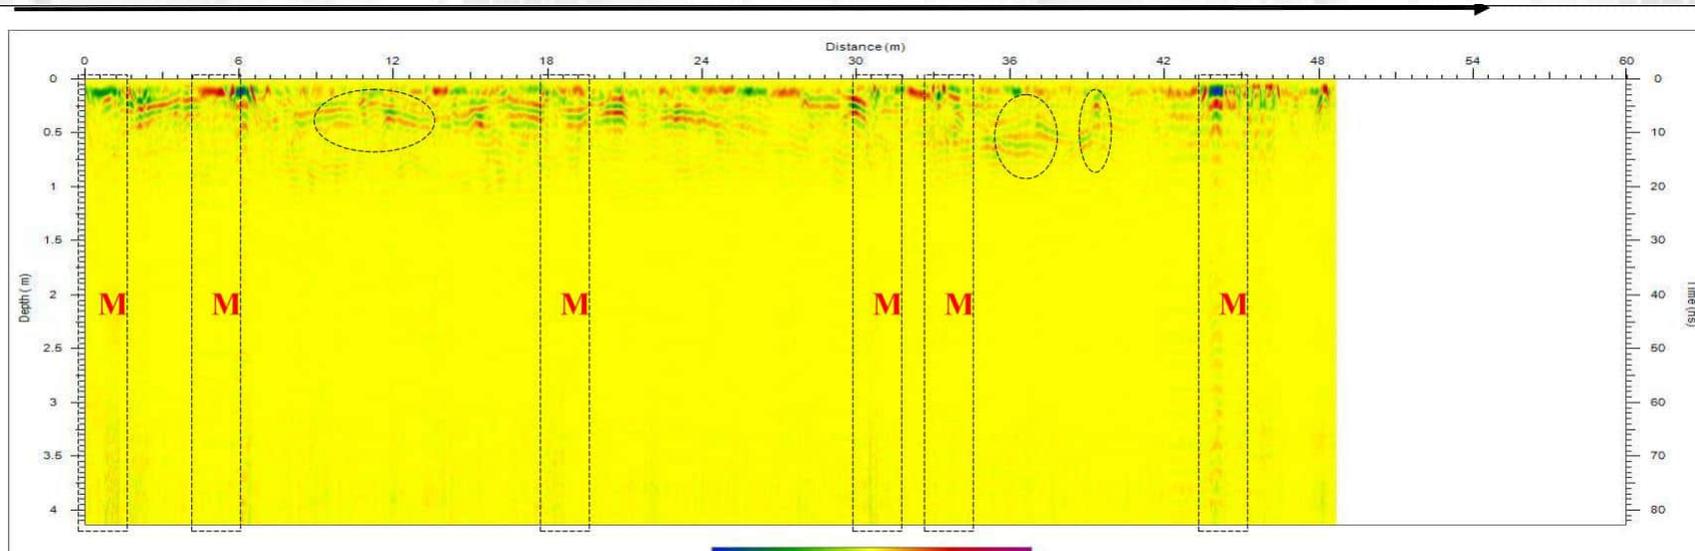
Proactive Measure for Ground settlement by Ground Radar Scan Survey

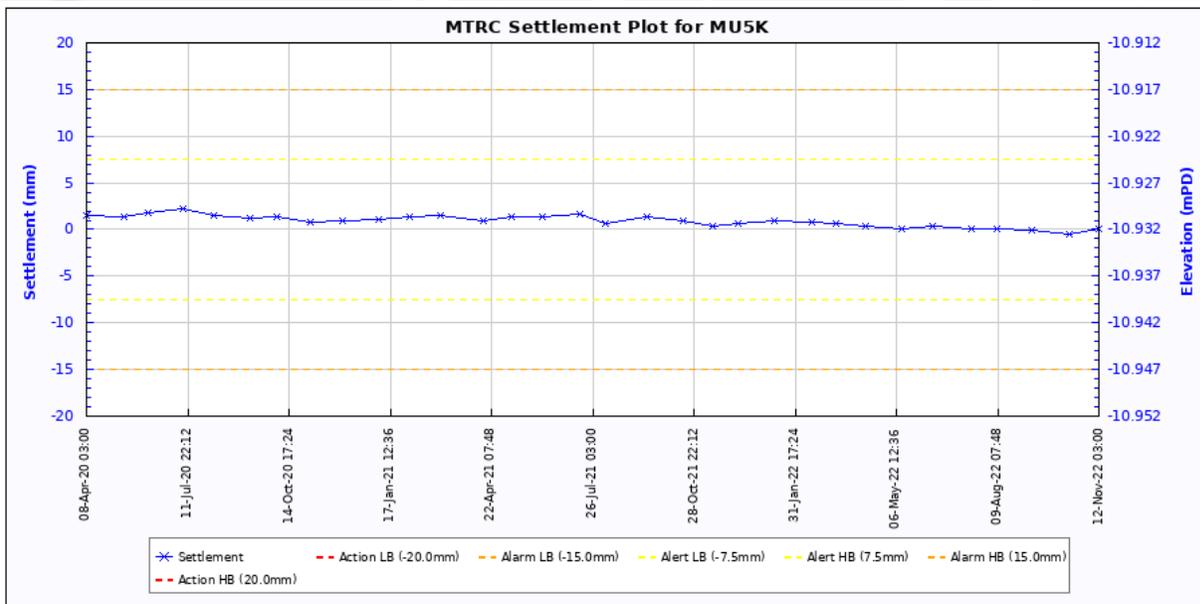
Settlement Data After Completion of the excavation work

1. Max. Tunnel Settlement is 20mm.
2. All the monitoring check point could keep within the alert level (-7.5mm).
3. The whole excavation work create less than 3.5mm tunnel settlement

Instrument	Alert	Alarm	Action
Tunnel settlement	-7.5	-15	-20

Summary for MTR Tunnel Settlement

Date of Survey	MTR Tunnel	Field Reading
10/01/2023	TWL Tunnel	0.2mm
04/02/2023	Island Line (Up track)	-4.0mm
04/02/2023	Island Line (Down track)	-1.0mm

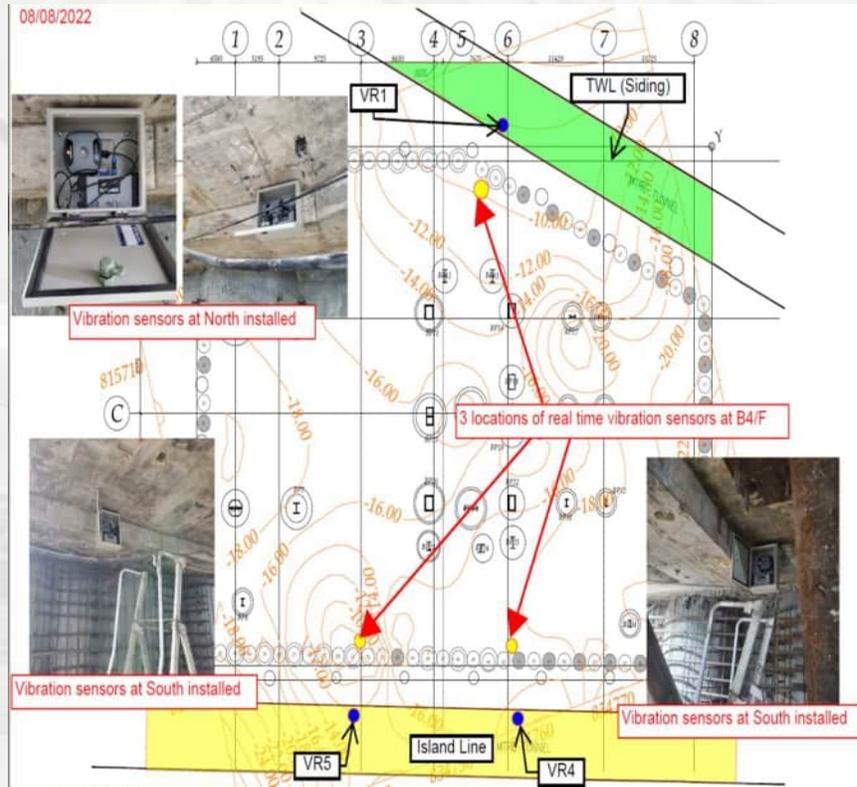
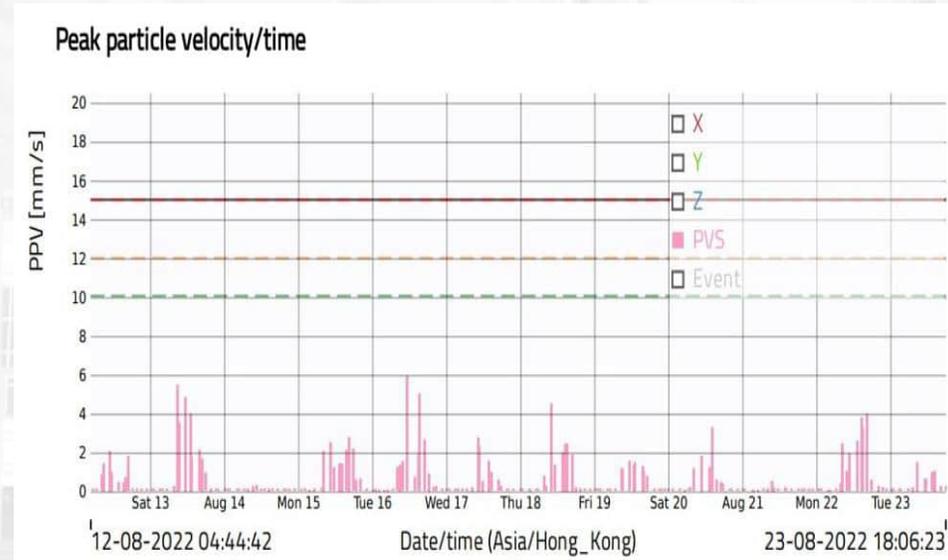
- Max. allowable vibration level is 15mm/s
- **Additional real time vibration Sensor for self checking which have more strictly control (10mm/s) than approval plan**

VB1
DUGITU
2022-07-13 8:34:03
X
Fd 1.0Hz
Vt 11.9mm/s
79.3%
Y
Fd 1.0Hz
Vt 7.4mm/s
49.3%
Z
Fd 3.0Hz
Vt 3.4mm/s
22.5%

VB1
DUGITU
2022-07-13 8:34:03
PVS
Vt 14.1mm/s
Fd 1.0Hz
94.0%

Real Time Notification for frontline

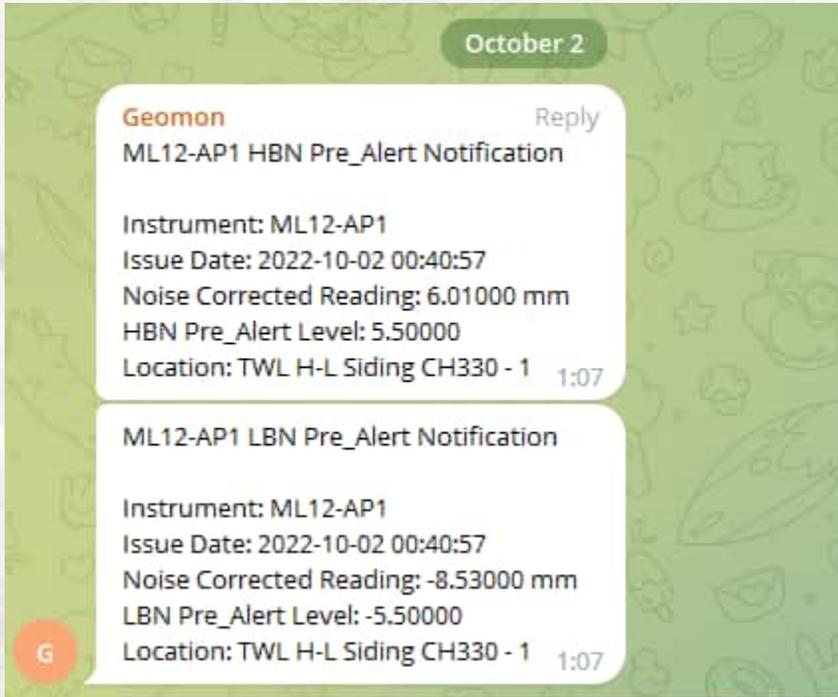
Pre-alert warning system from
GEOMON for site staff

Pre-determine action plan

Stage 1: Mechanical Breaker Method

Stage 2: Pre-splitting Method

Stage 3: Saw-cut Method

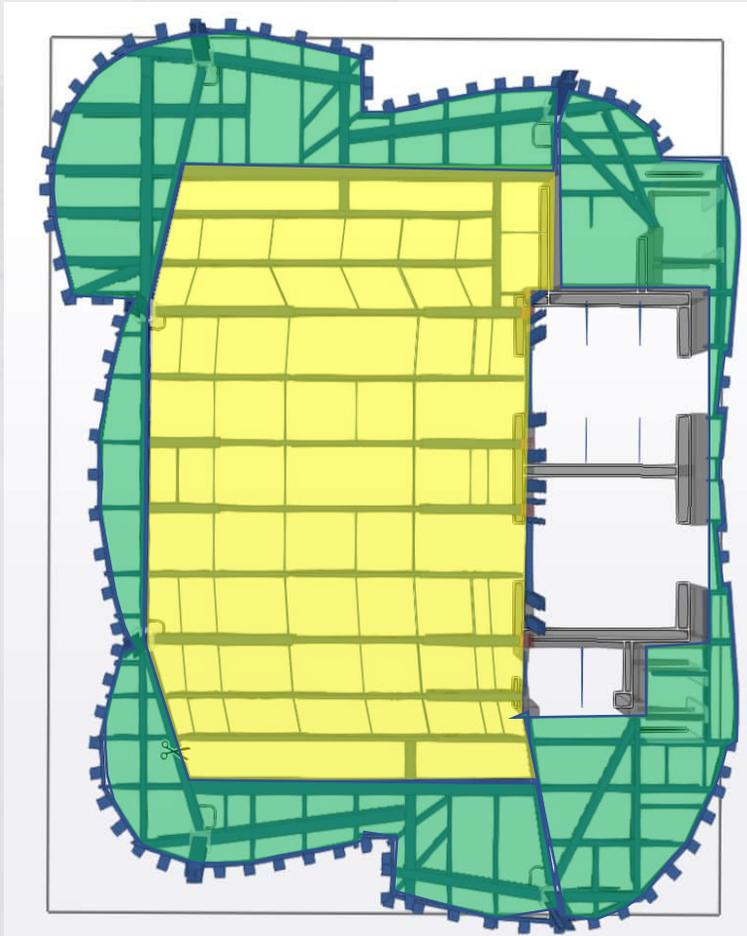
5. Different floor footprint on each floor

Long Span Truss Beam (22m)
-

Non-typical Cantilever Edge Structure (8.7mx7.5m approx.)

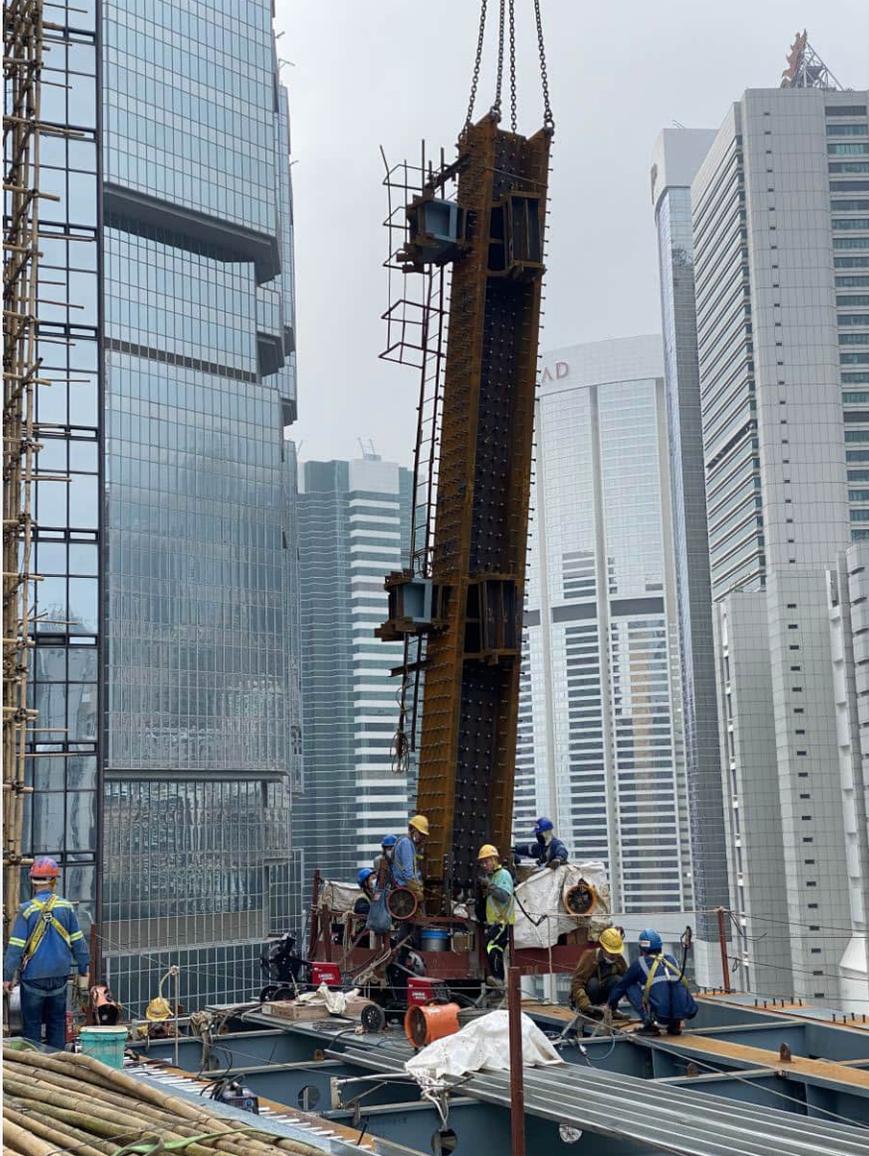
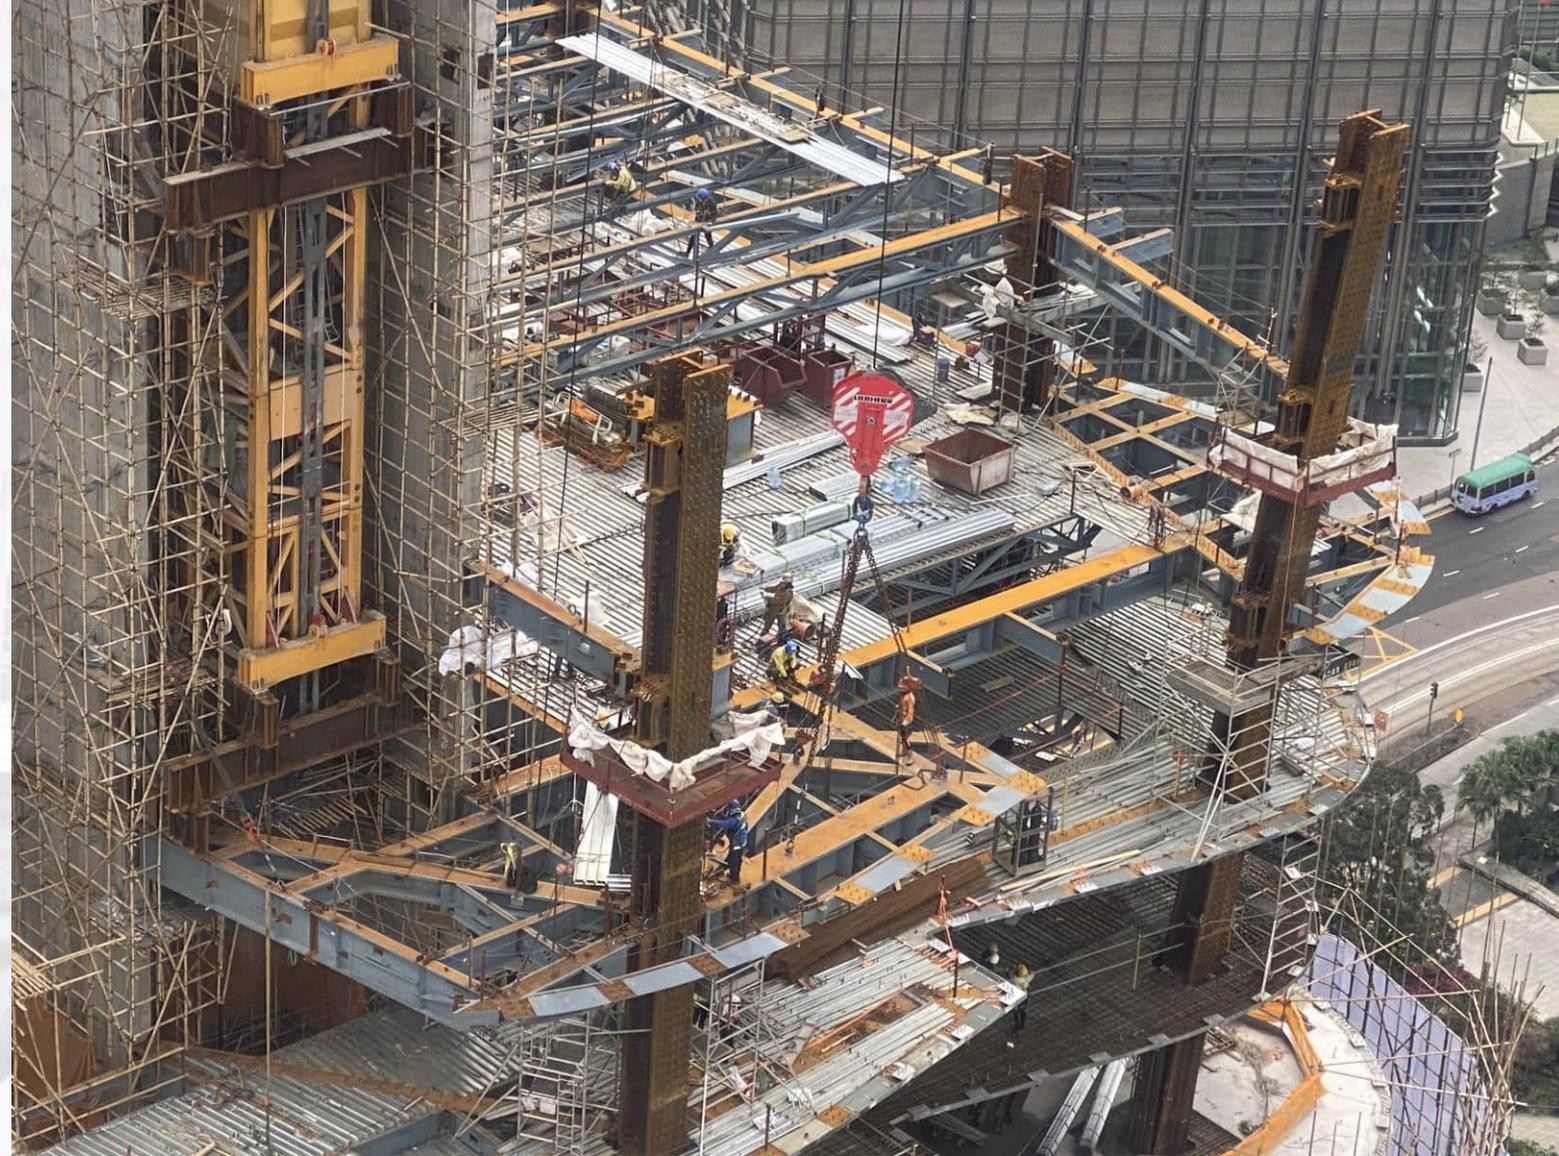
5. Different floor footprint on each floor

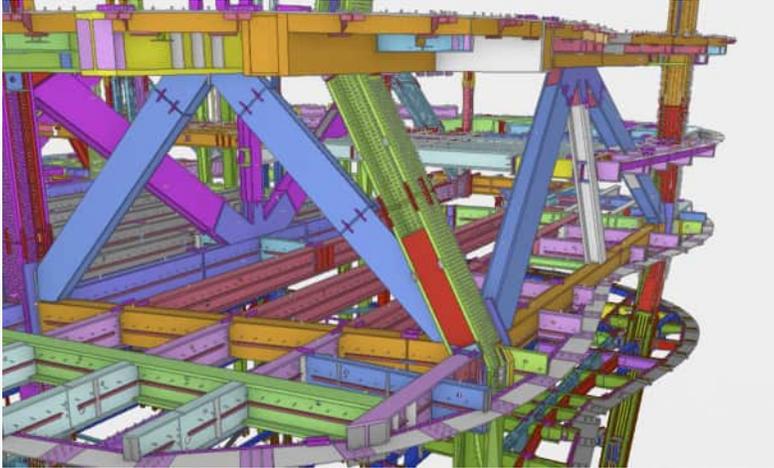
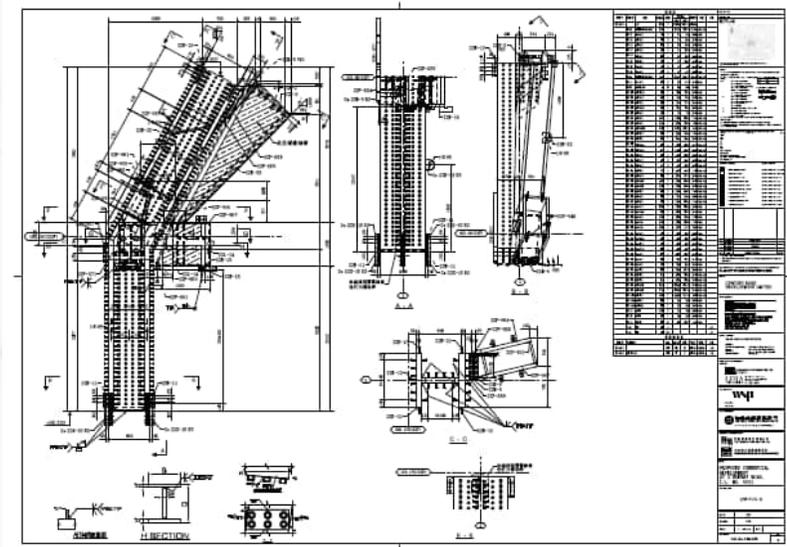
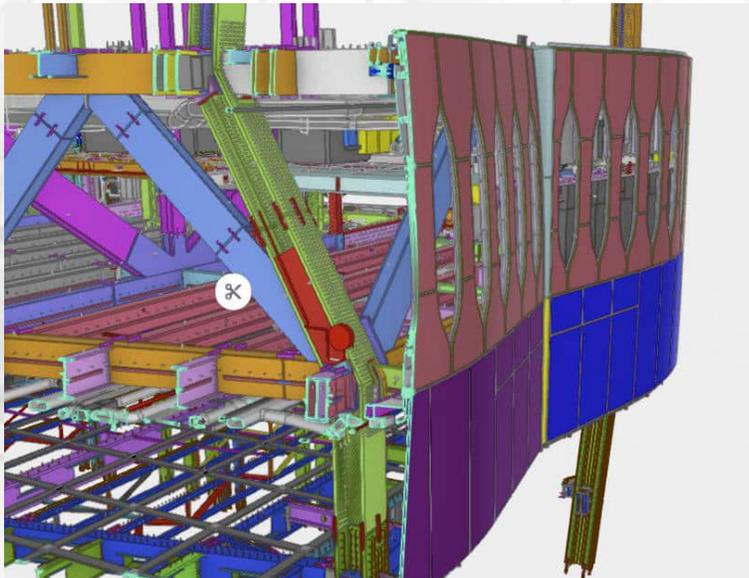
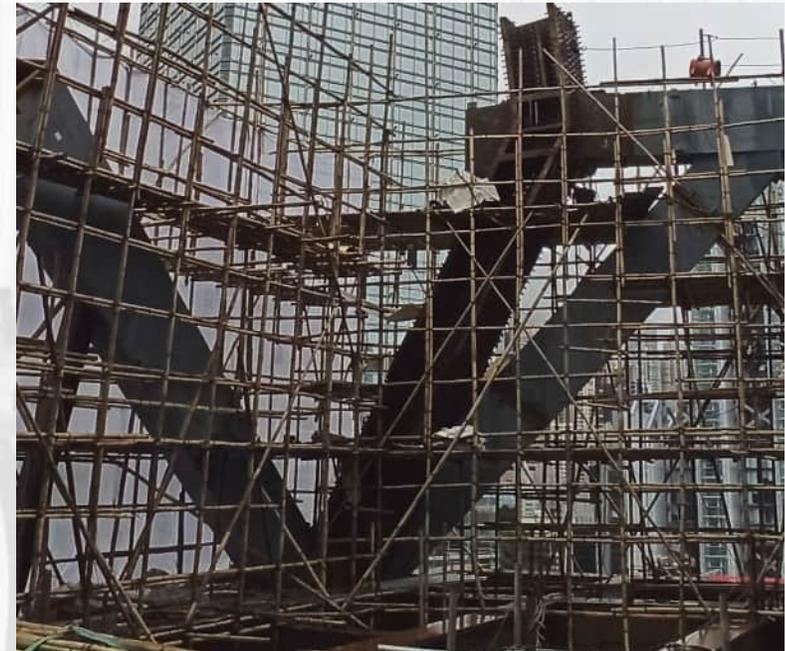
Structural Steel Construction with unusual footprint

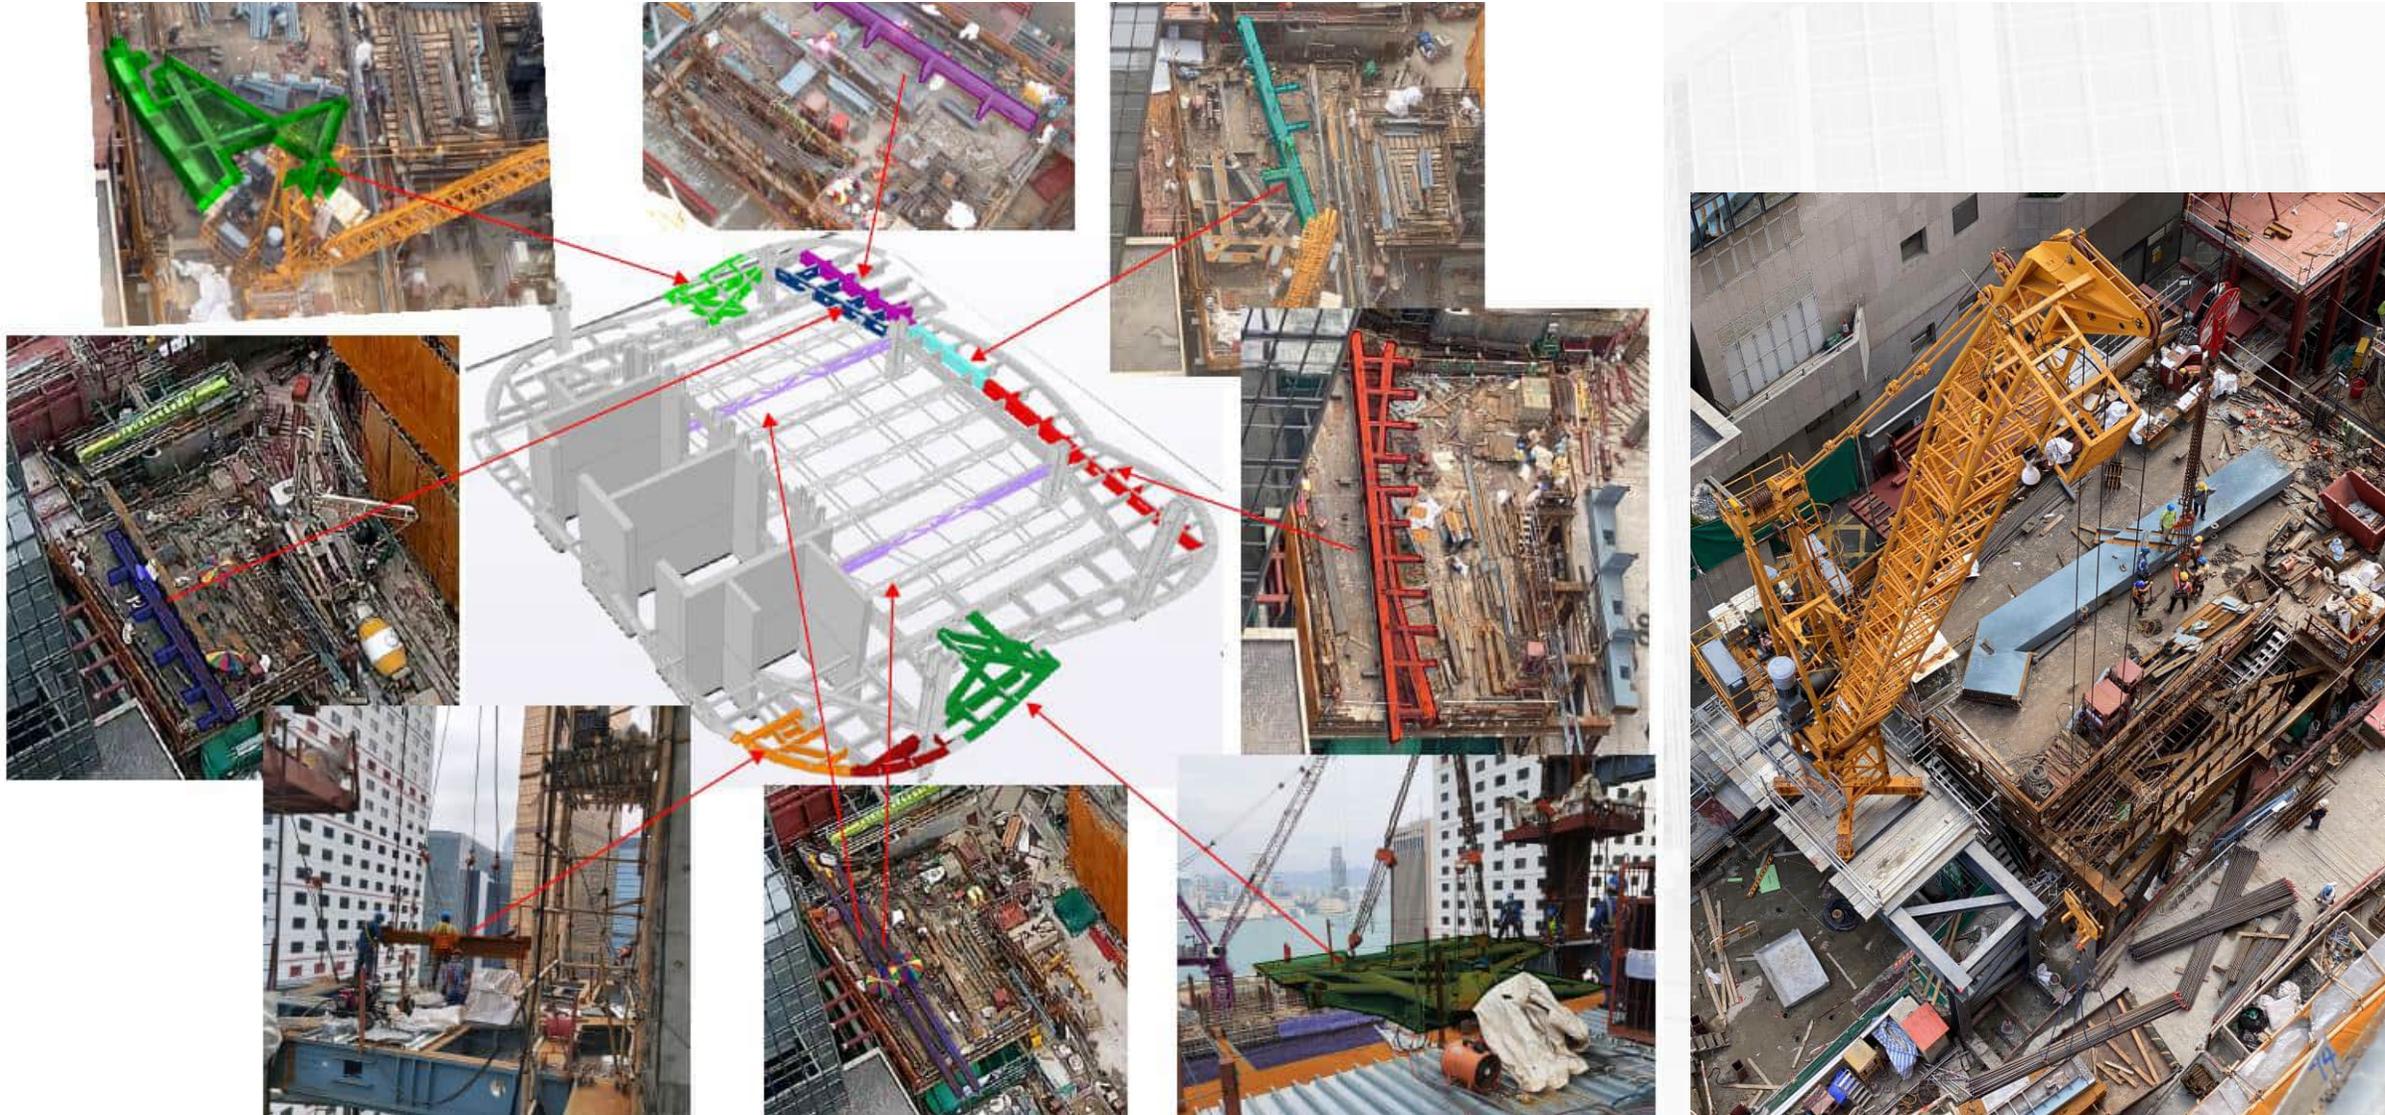
6. Limited site area to handle 22m long span truss and 8.7m x 7.5m large cantilever edge panels

Requirement of large working platform for pre-assembly
