2 Murray Road
(Central)
中環美利道2號

20240525 HKIE Technical Visit (BUD) The Henderson

1. Project Profile

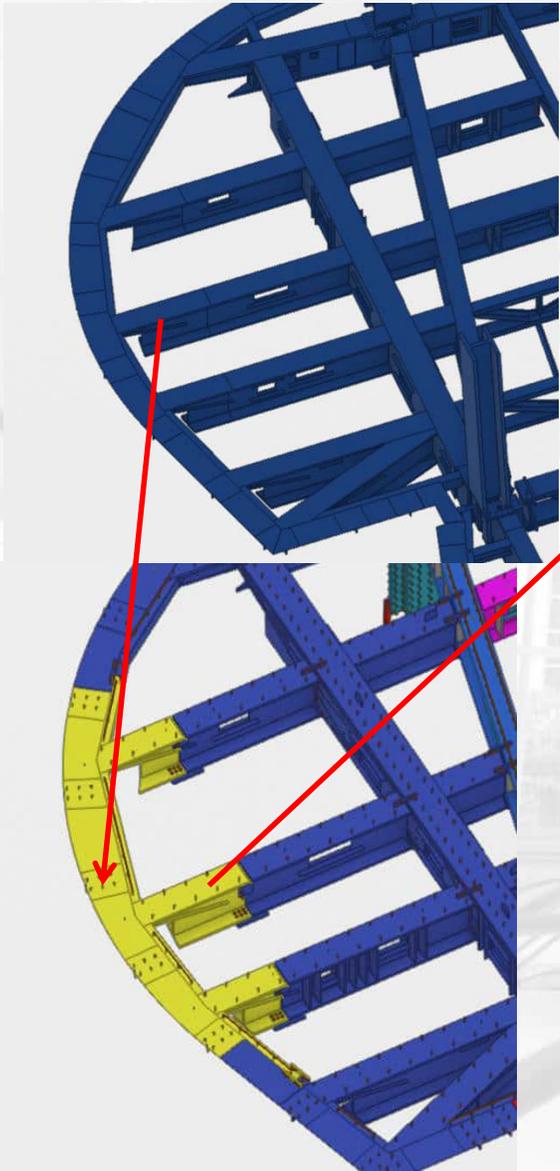
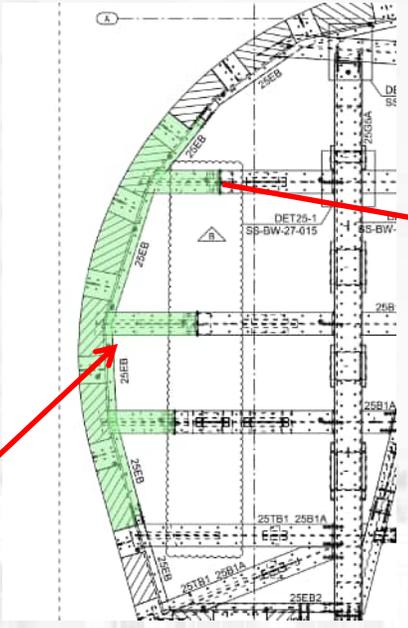
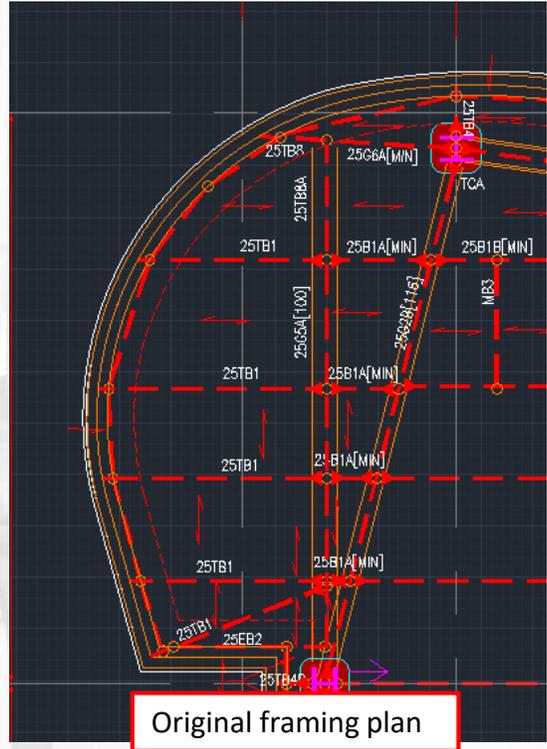
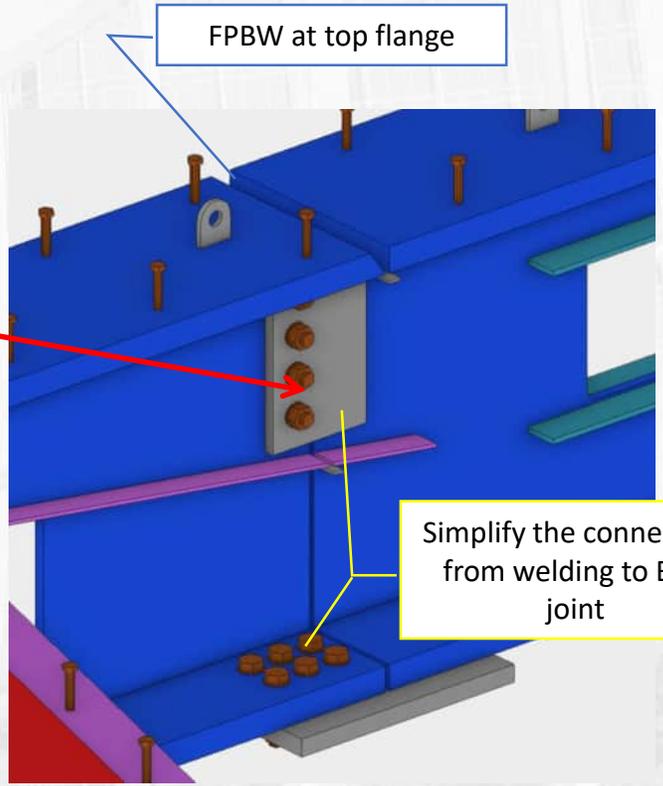
Simplify the connection detail between the cantilever edge sub-modules to improve productivity and safety.

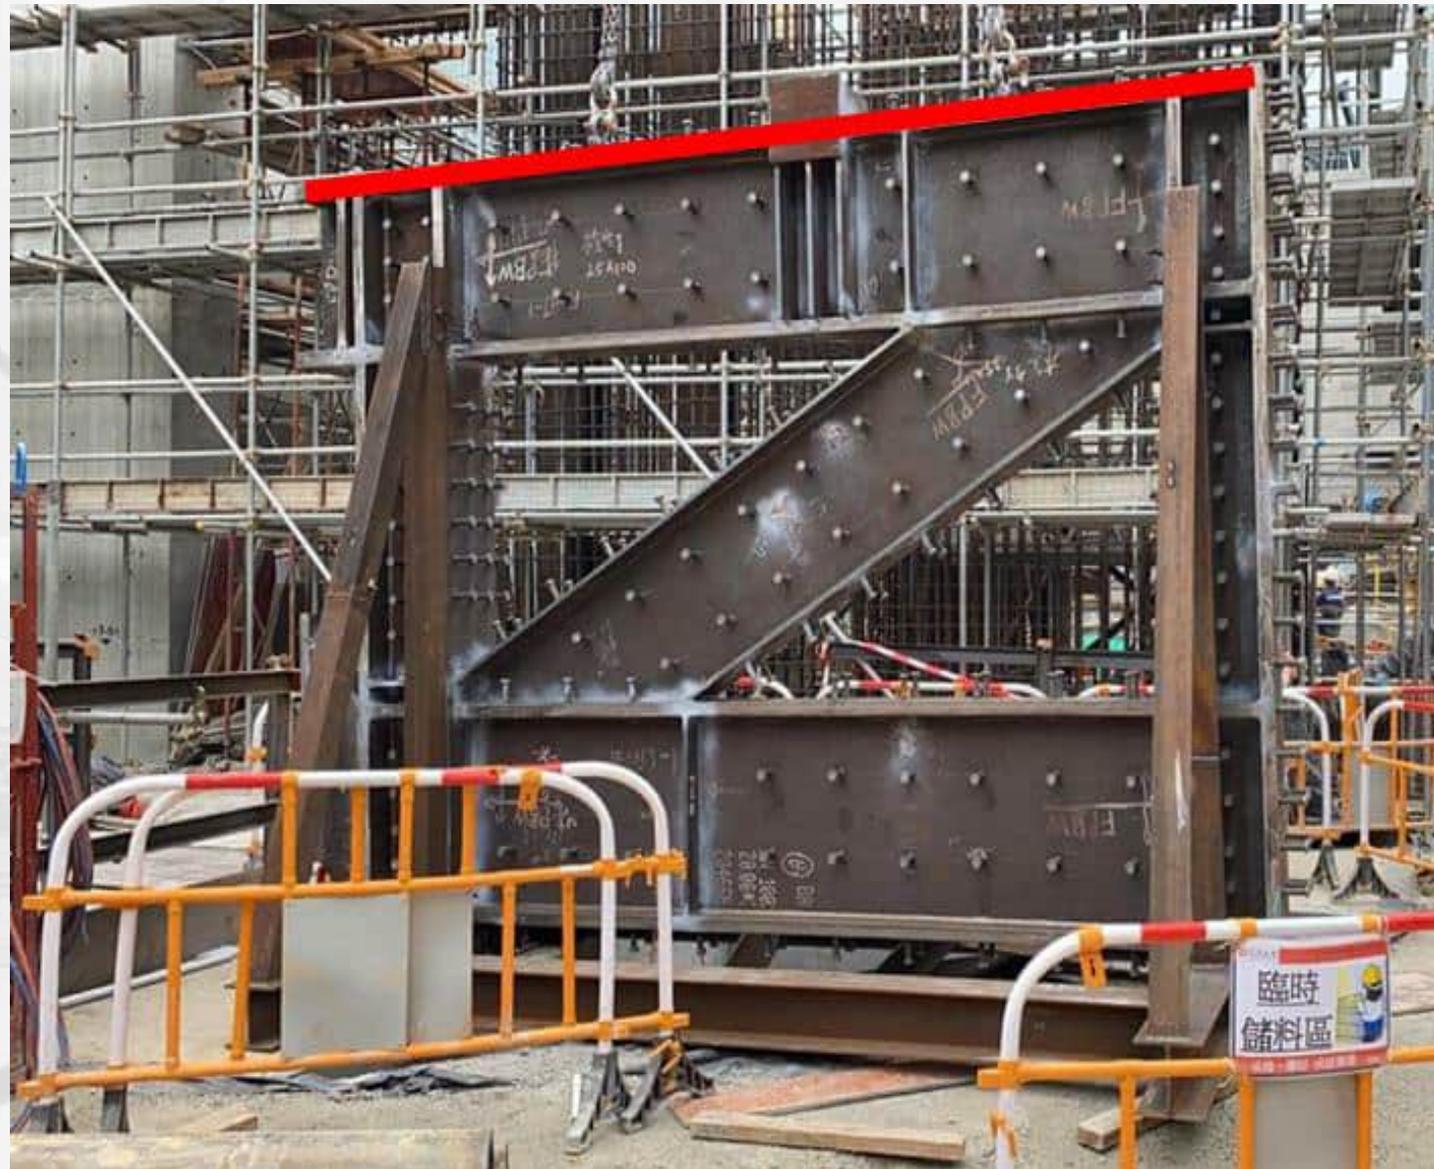
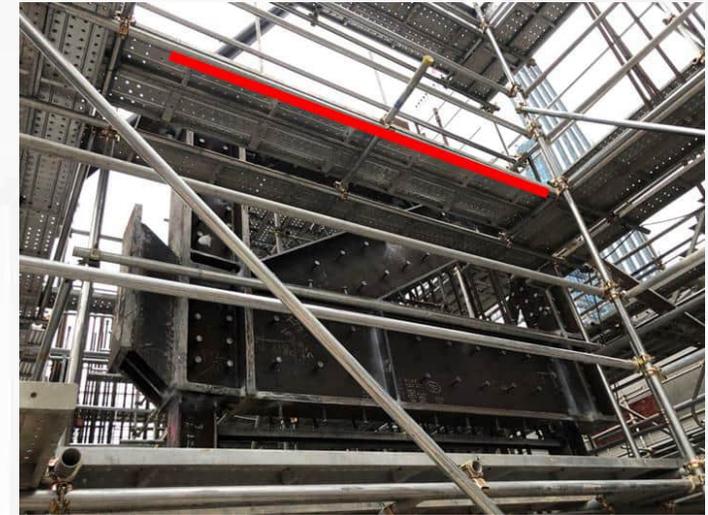
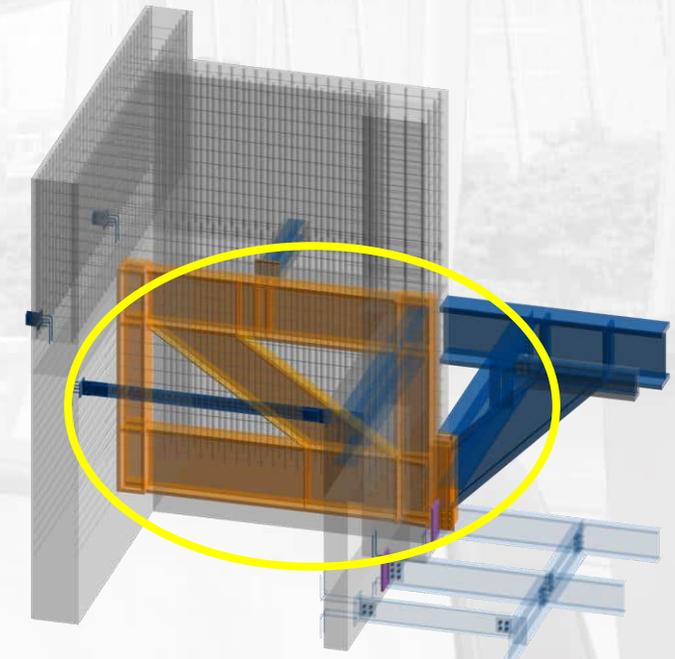
Additional Steel Frame in 1/F Core wall (PW3)

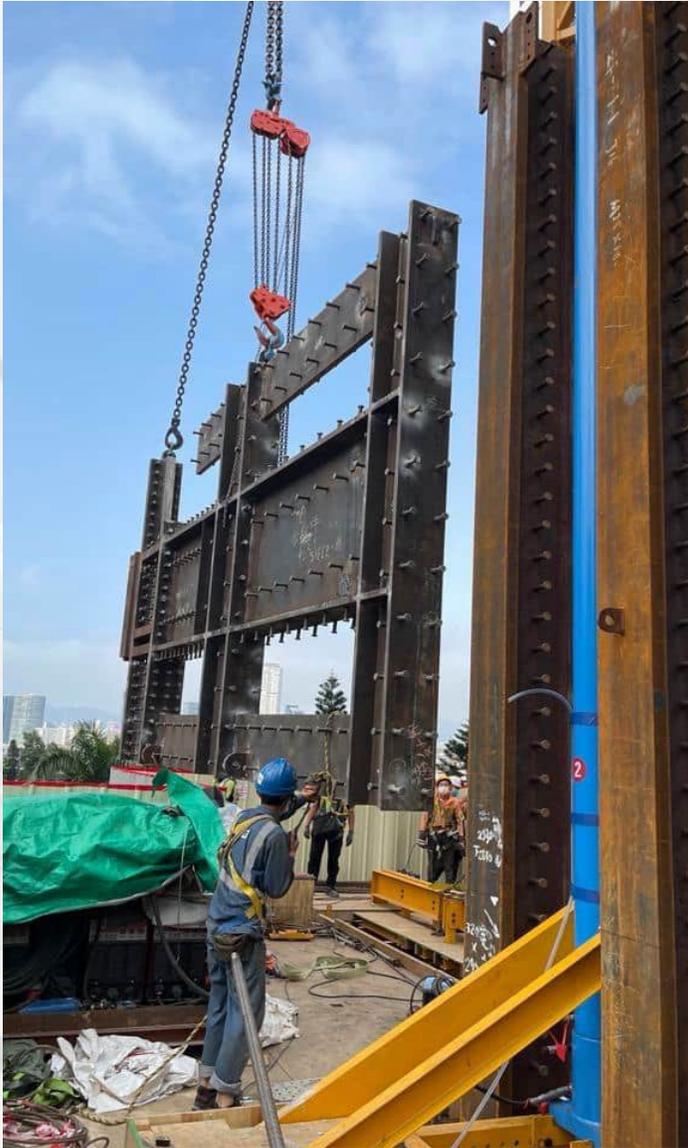
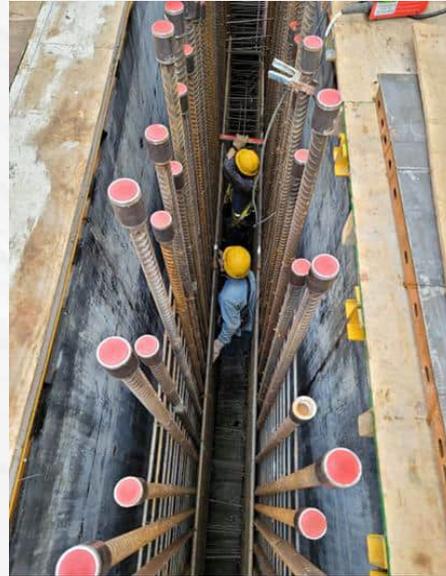
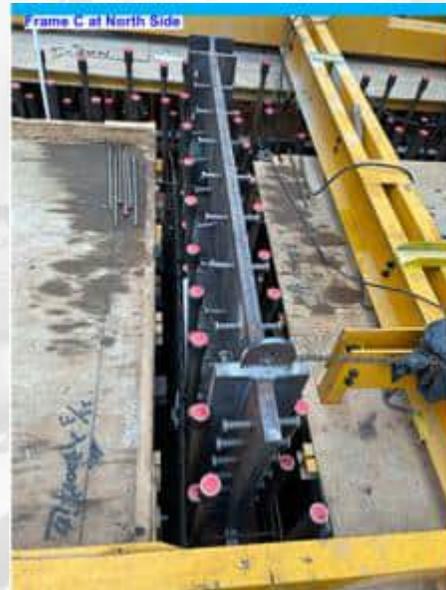
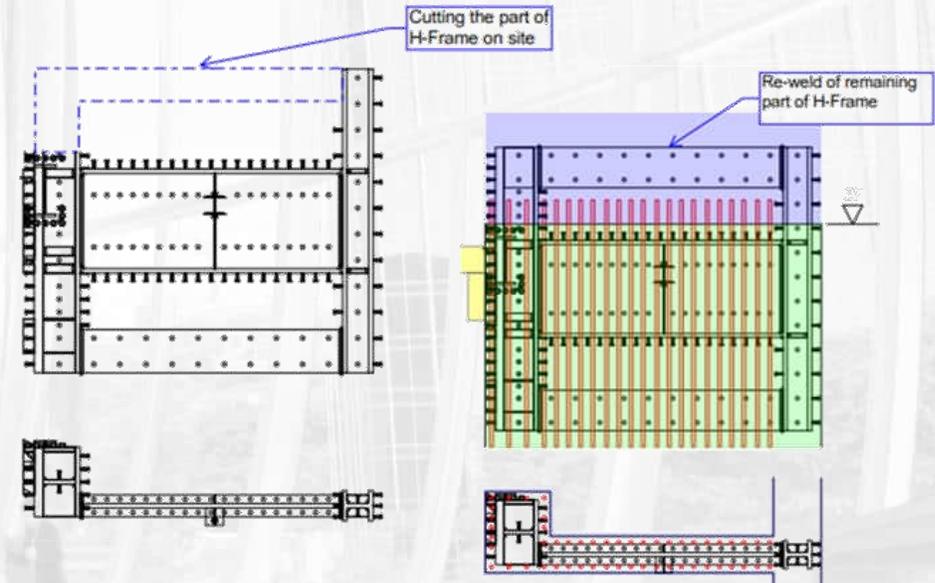
Additional Steel Frame in 3/F Core wall (PW3)

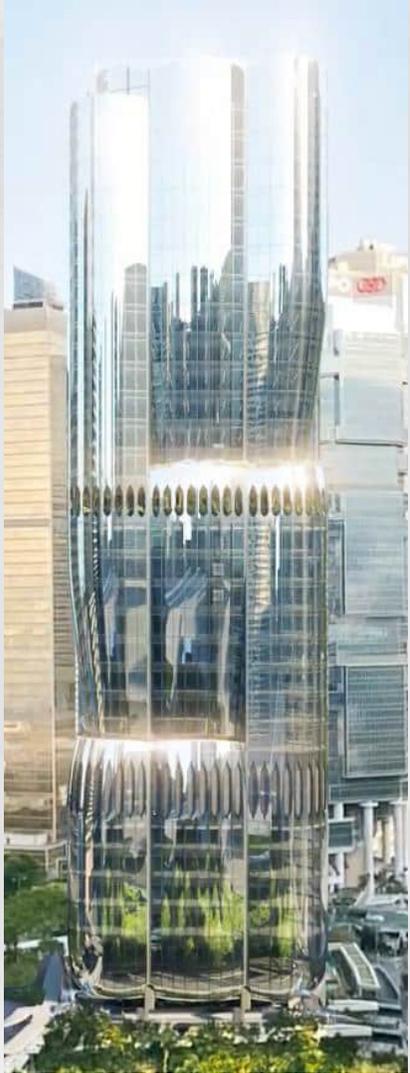
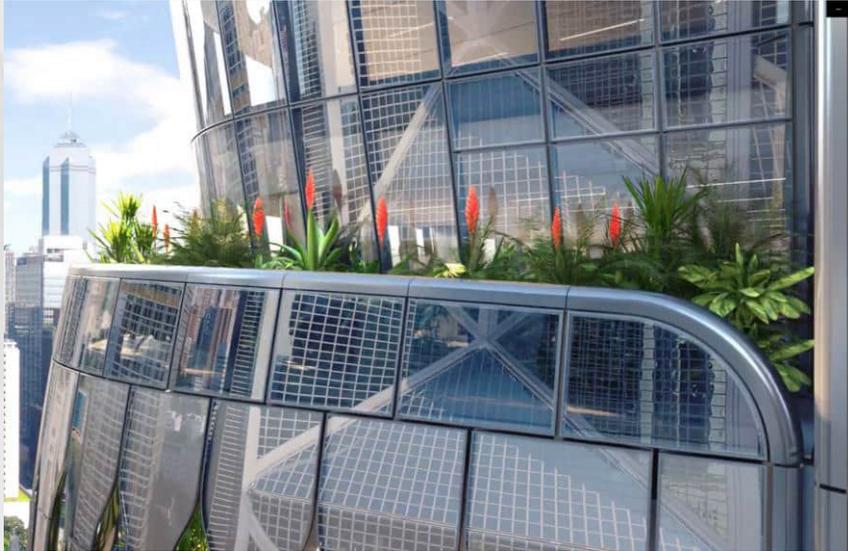
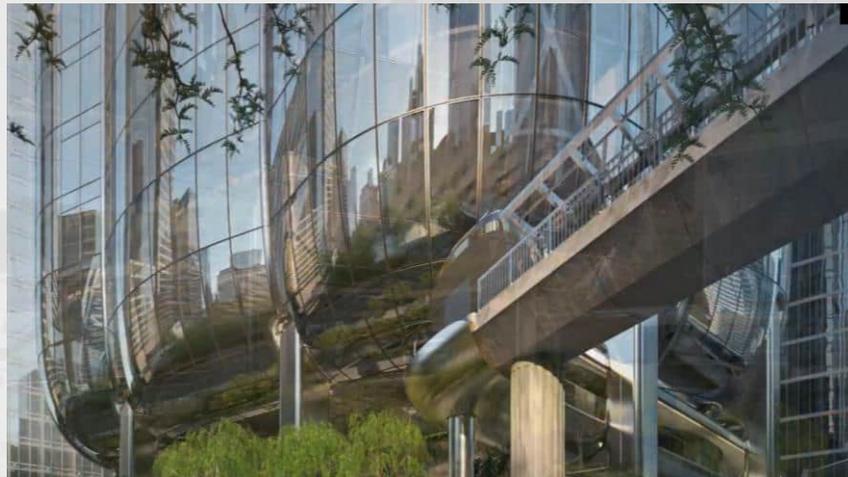
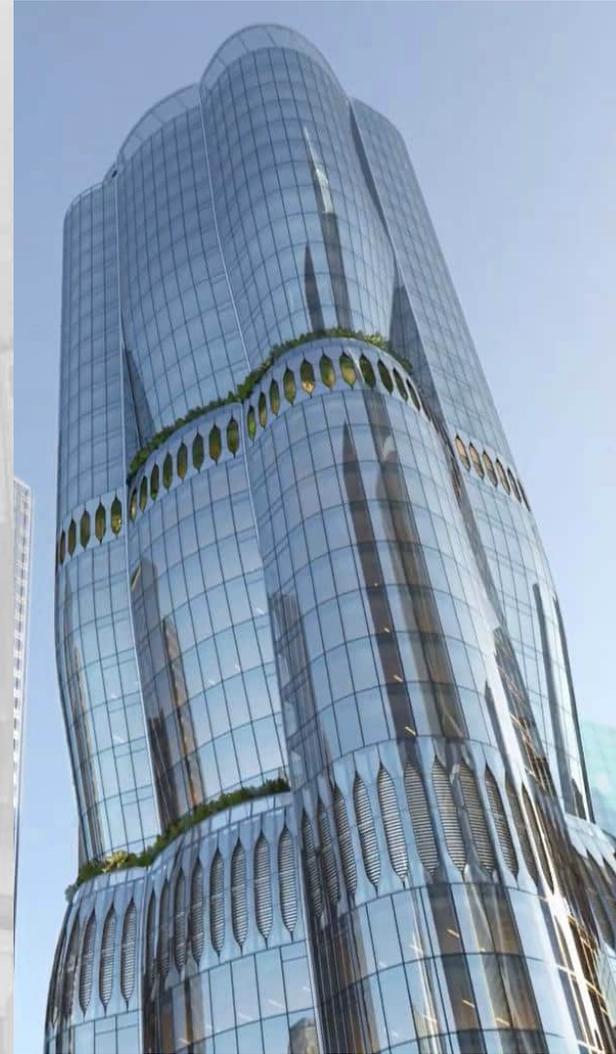
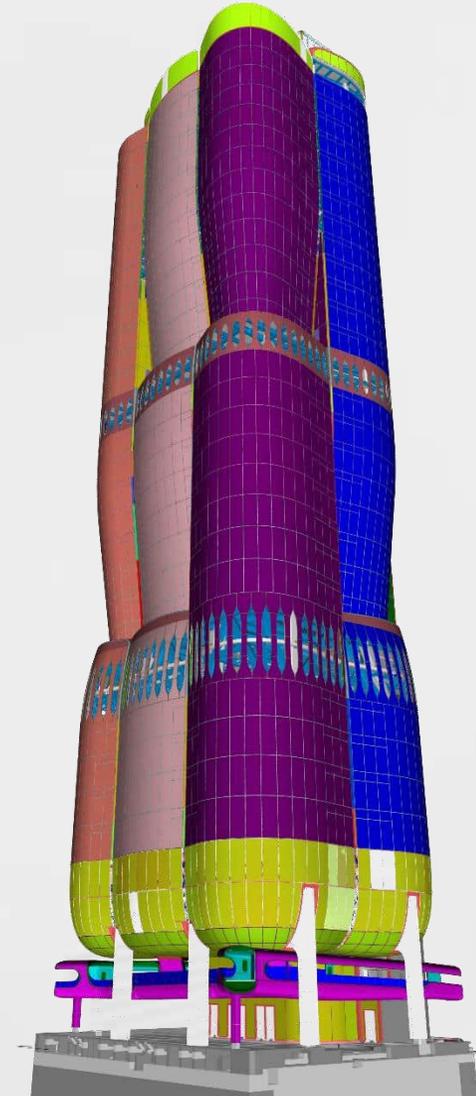
8. Double curve external façade impose tighten QA/QC on production glass panel and erection

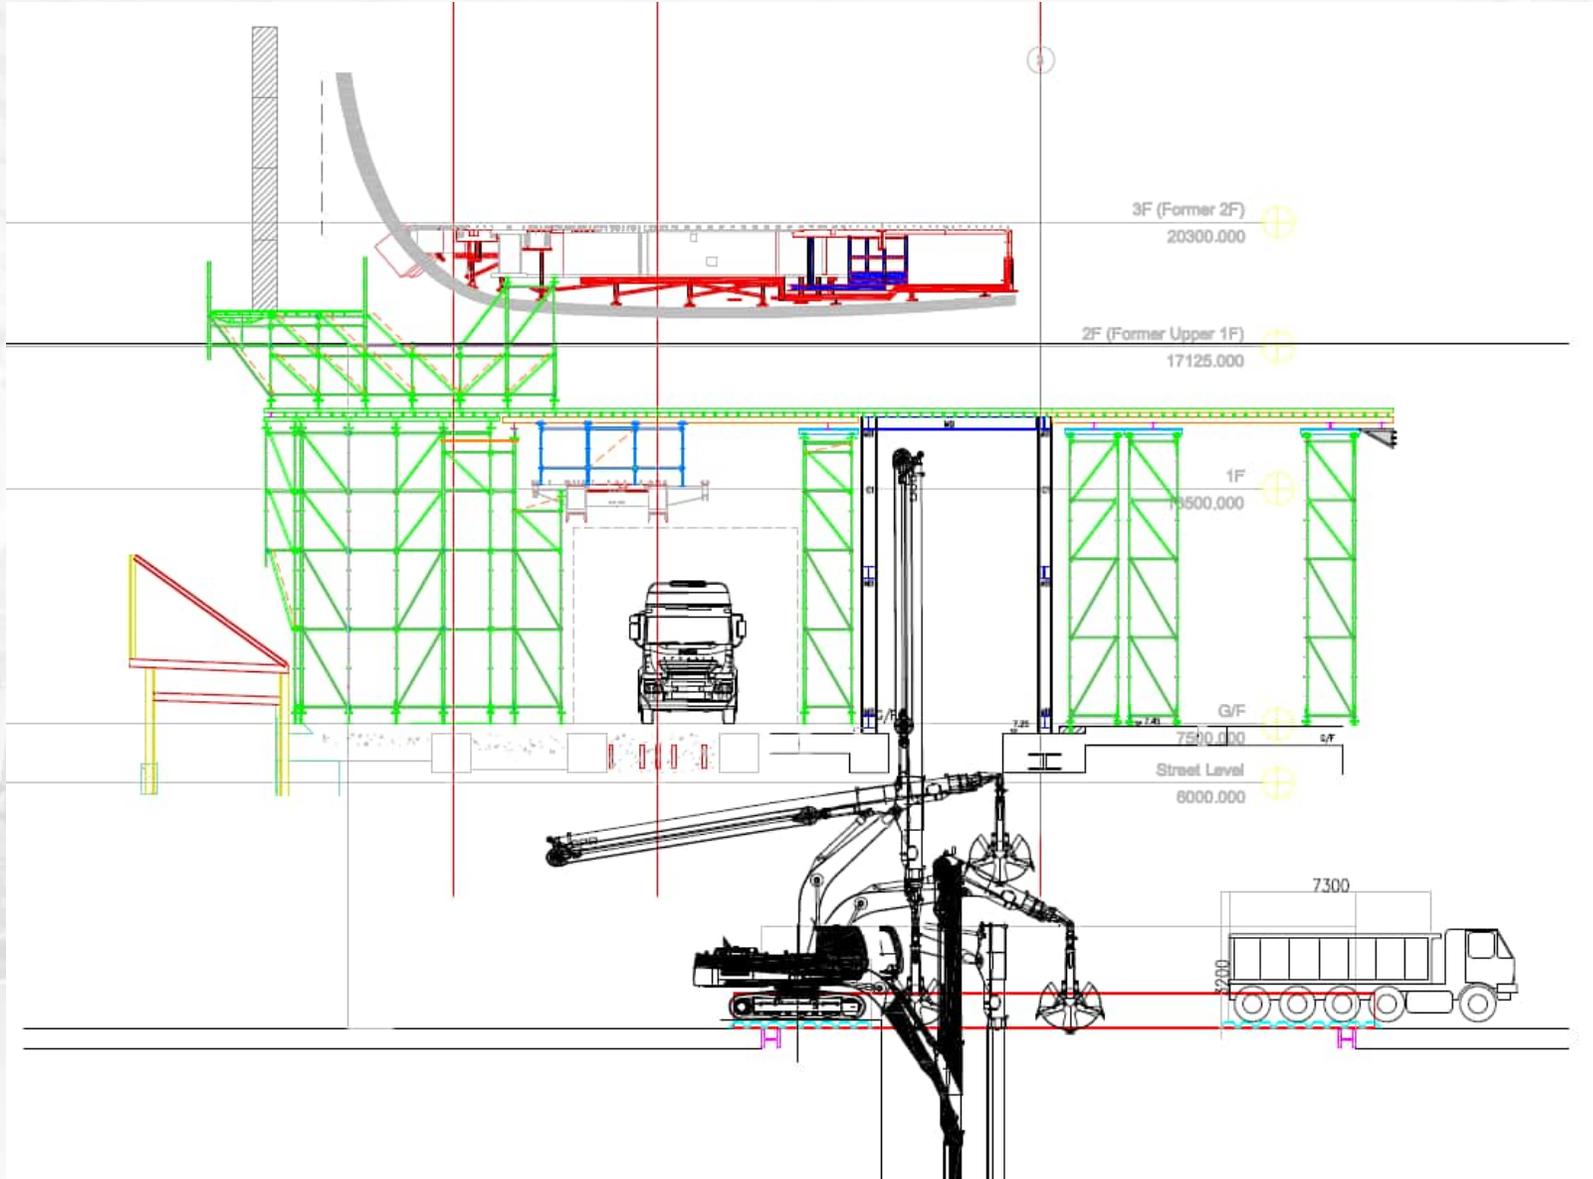
Temporary Working Platform for Underslung construction

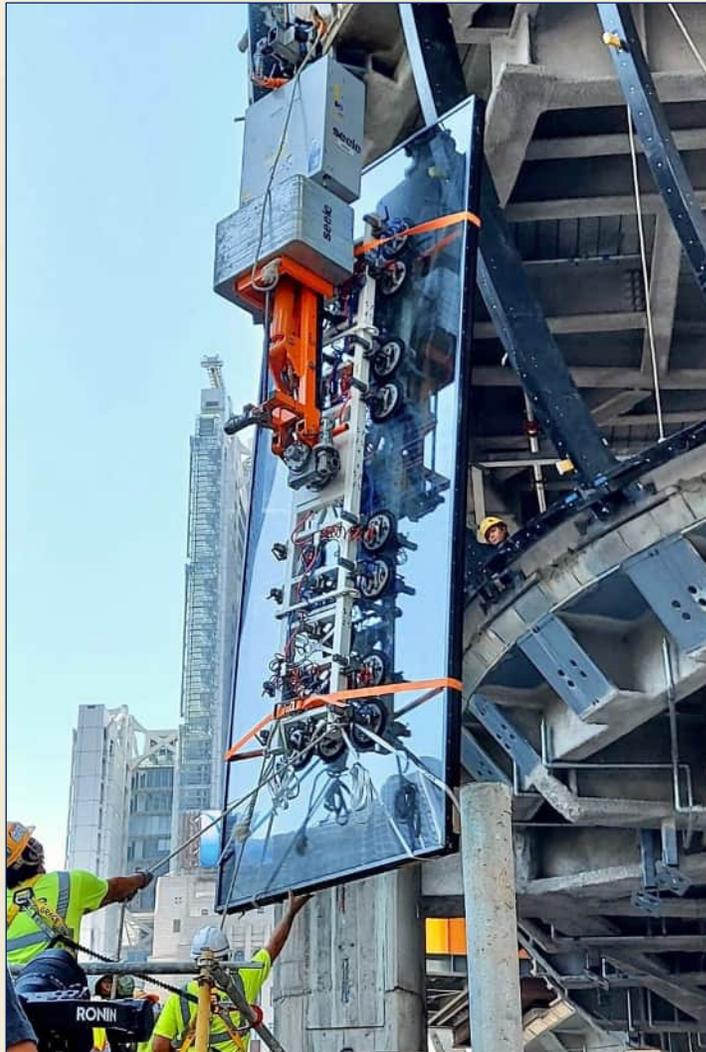
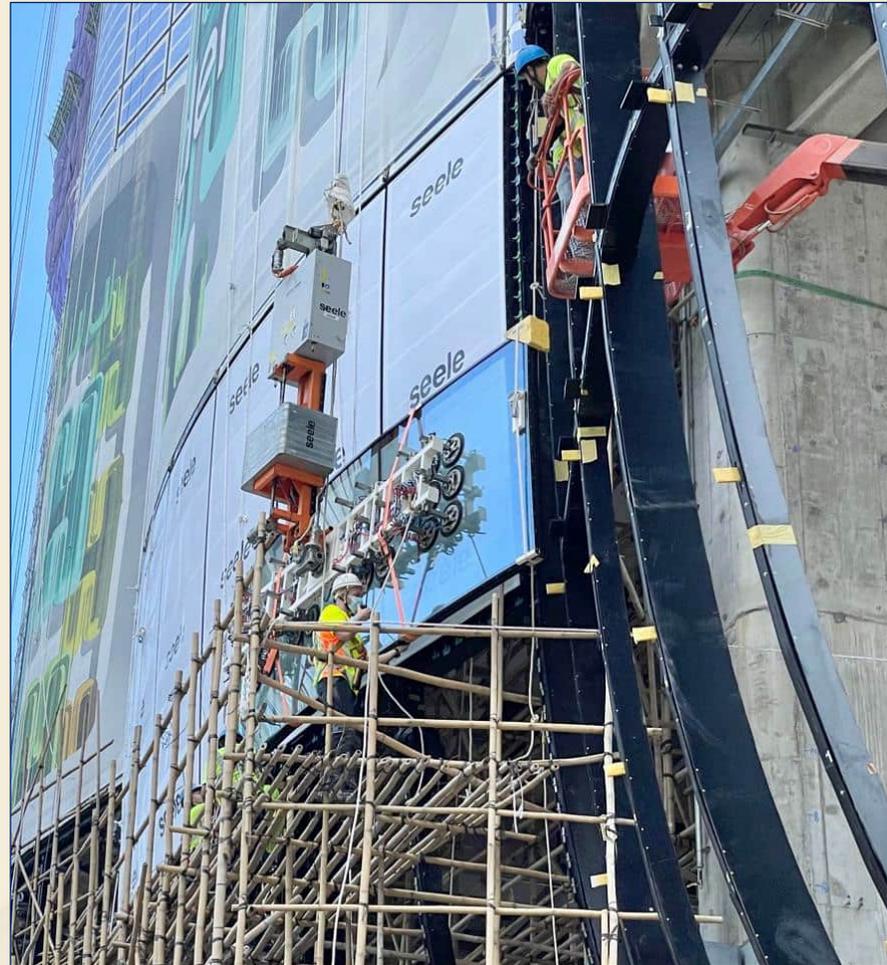
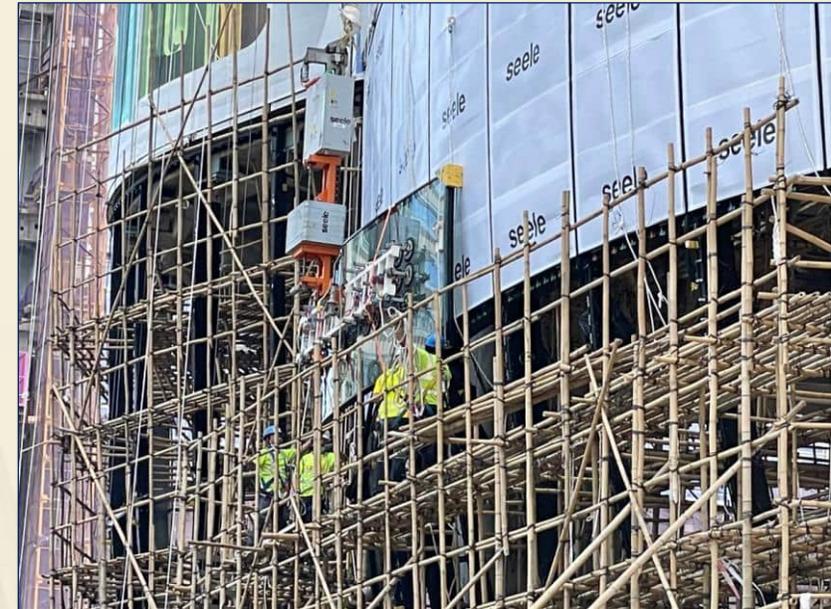
Congested Site Condition

We erected working platform and scaffolding for curved glass installation.

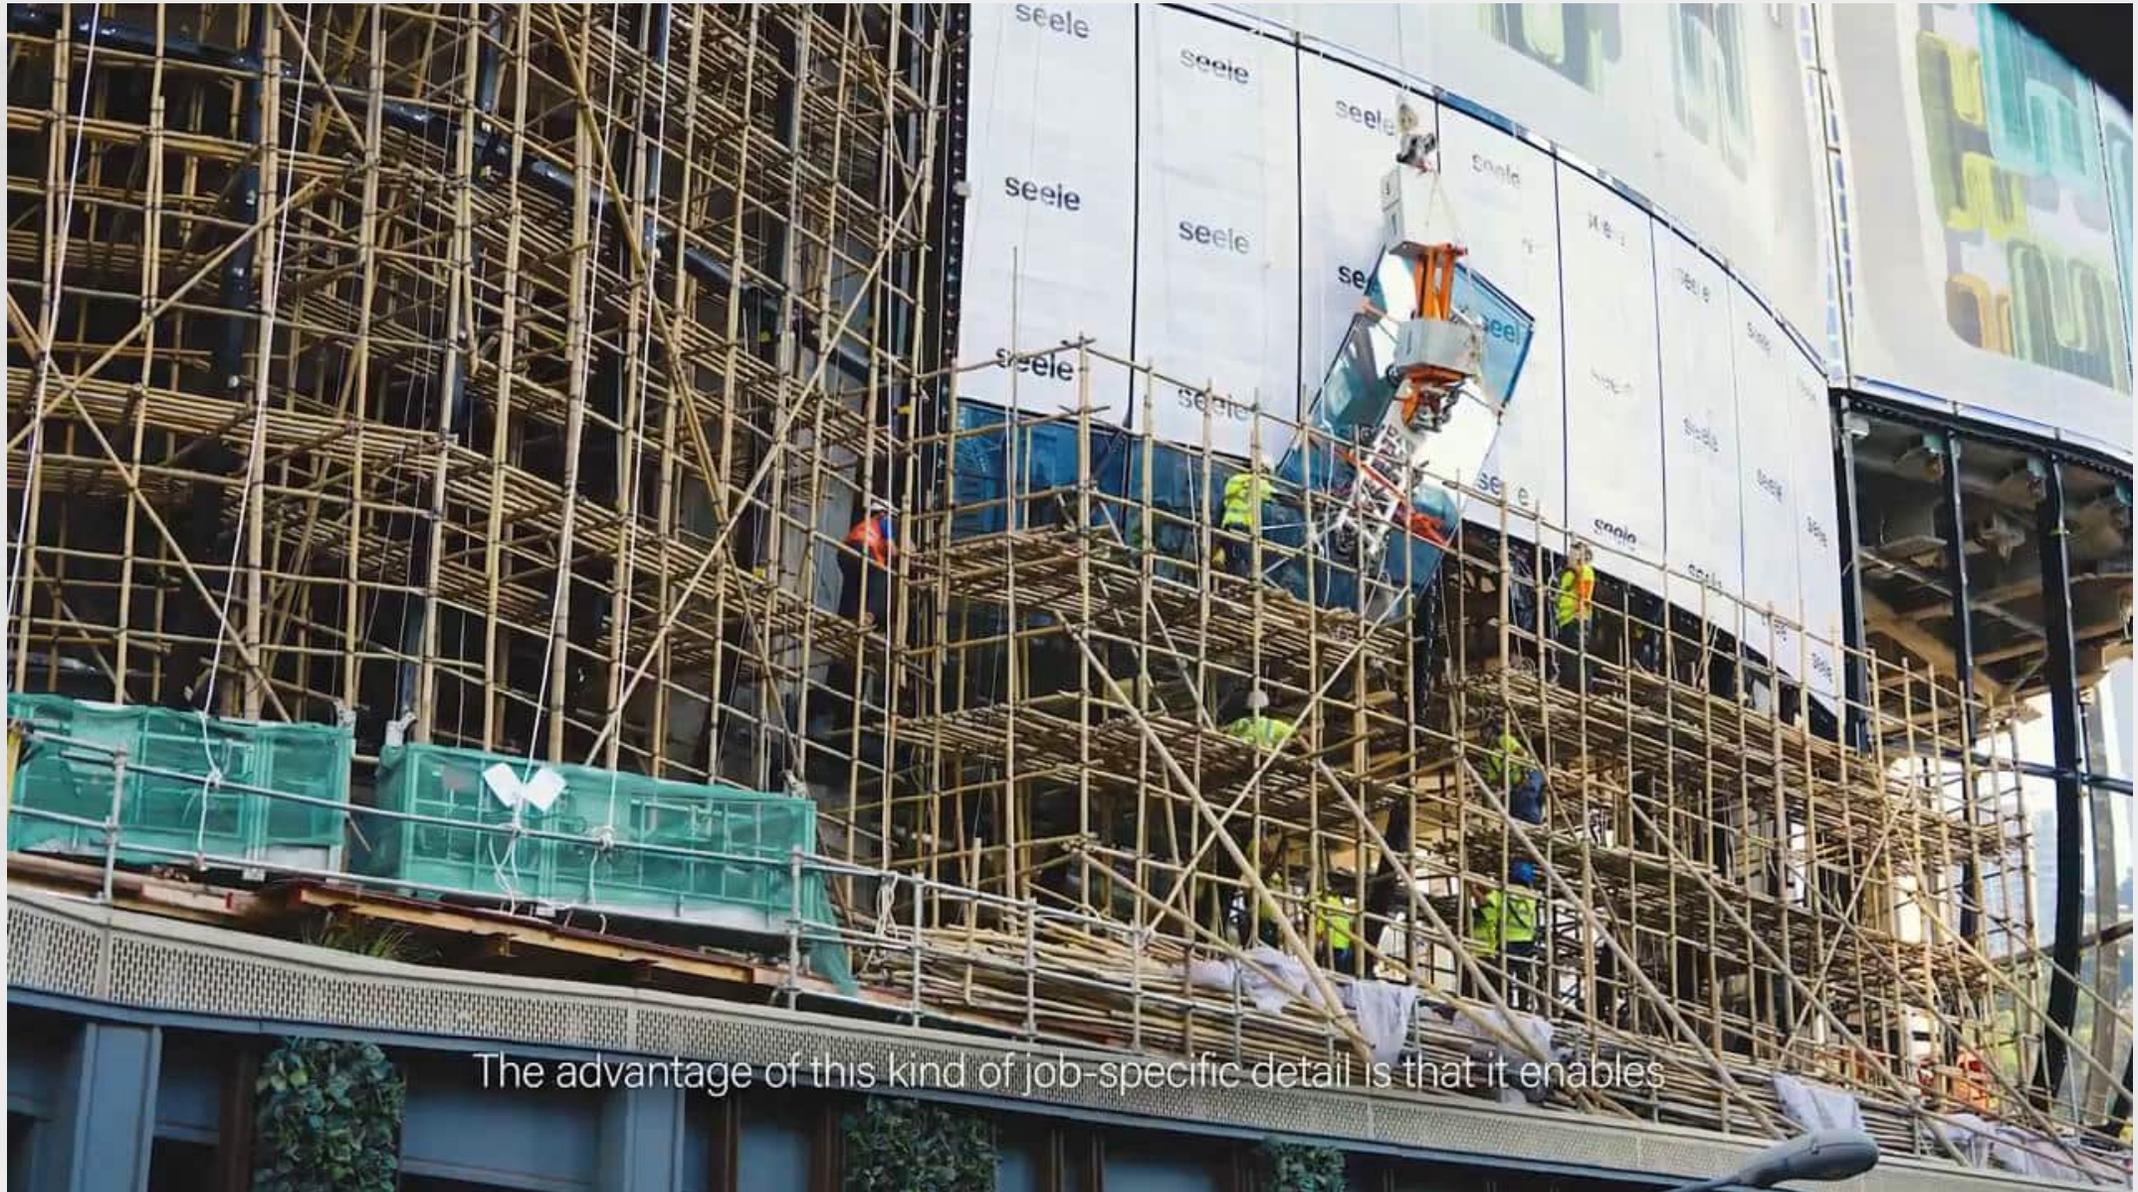
Curved Glass Lifting and Installation

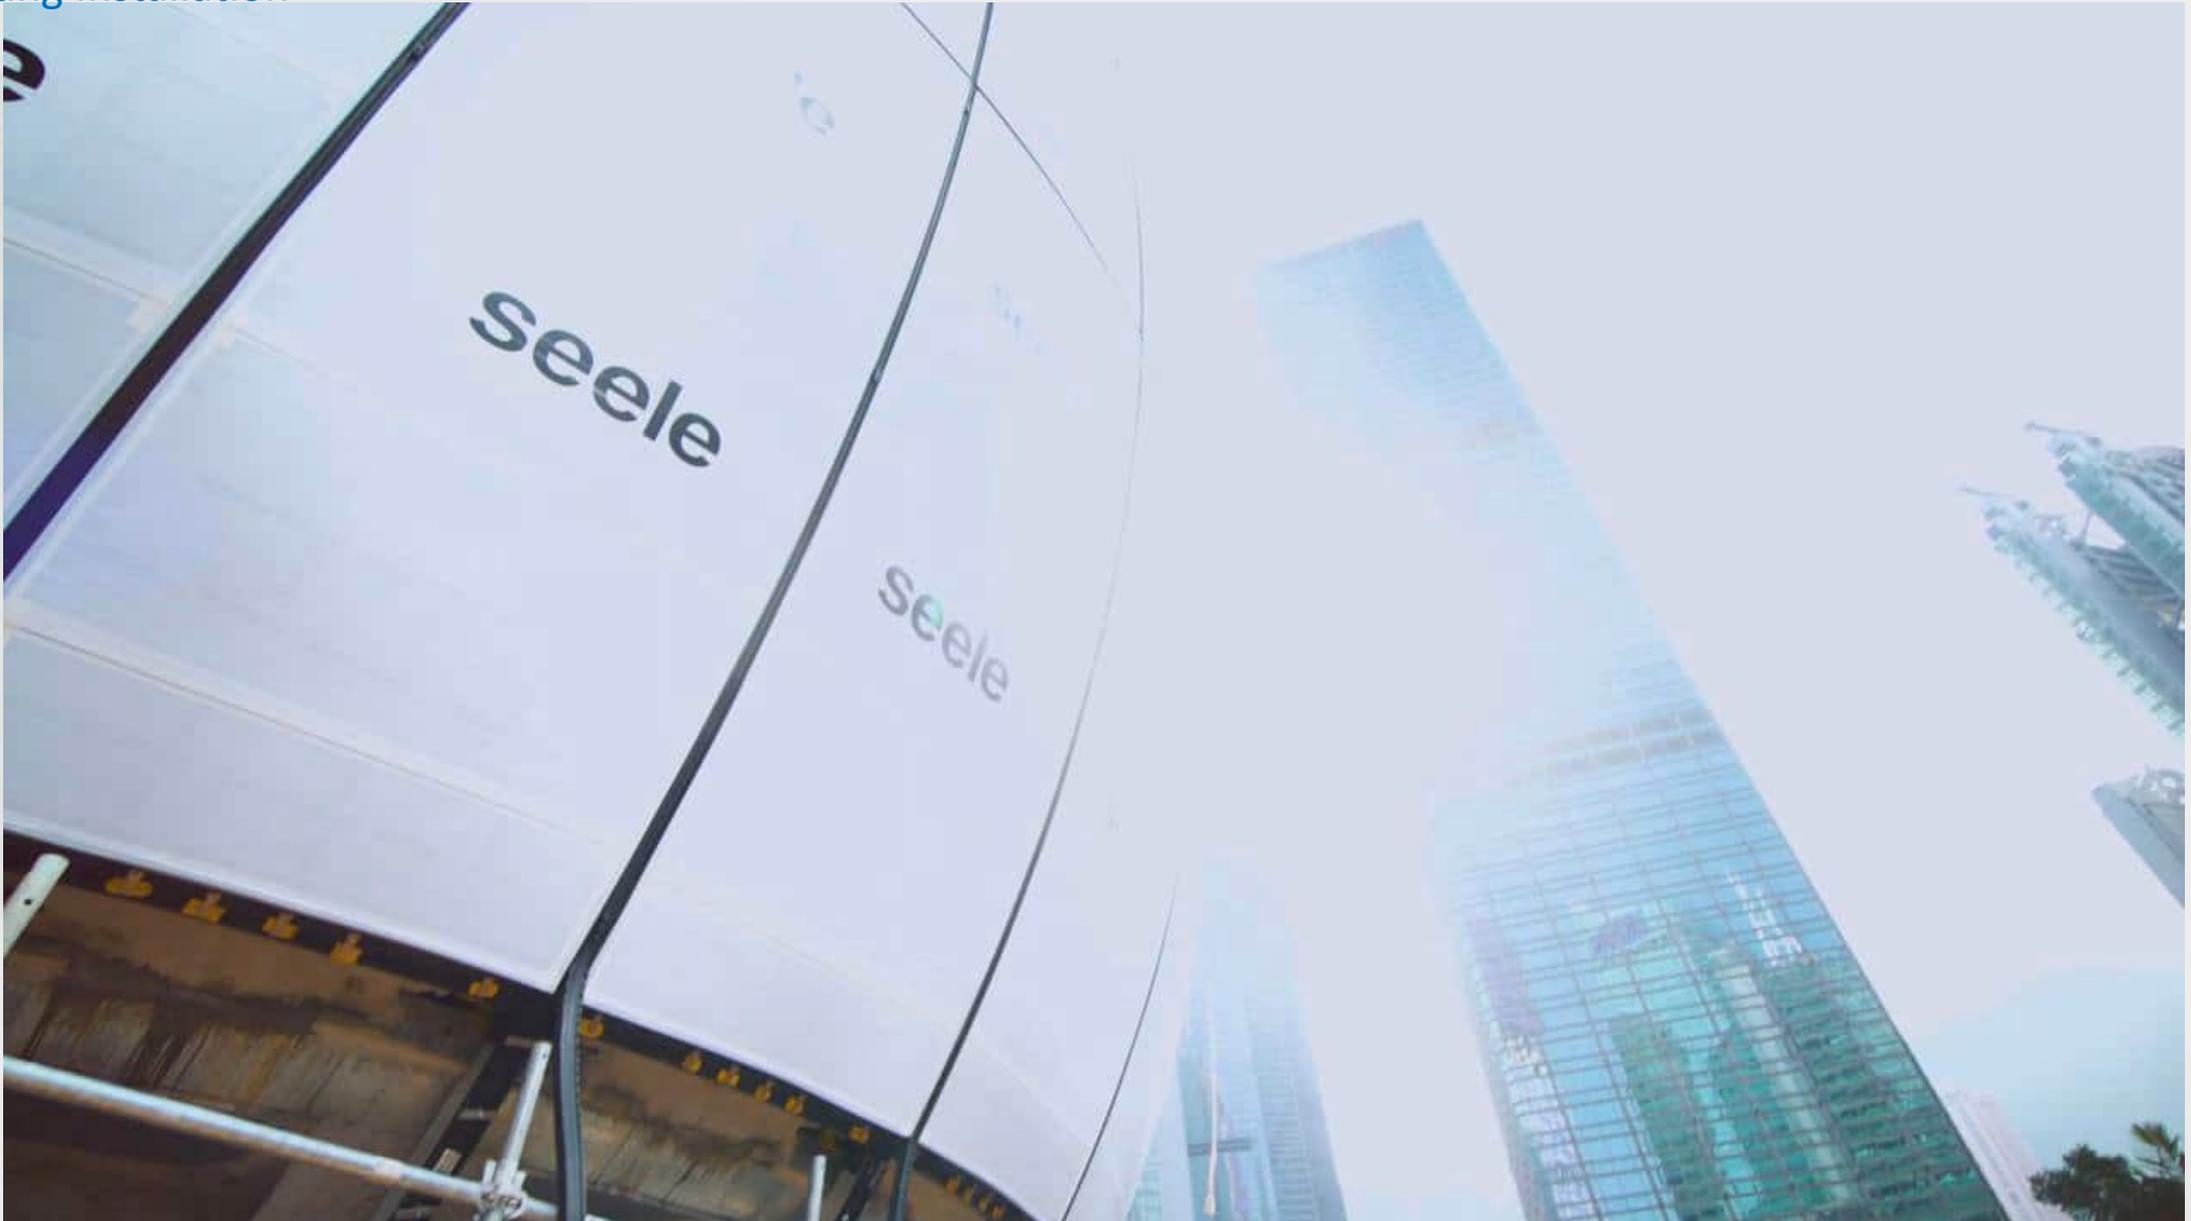
Underslung Installation

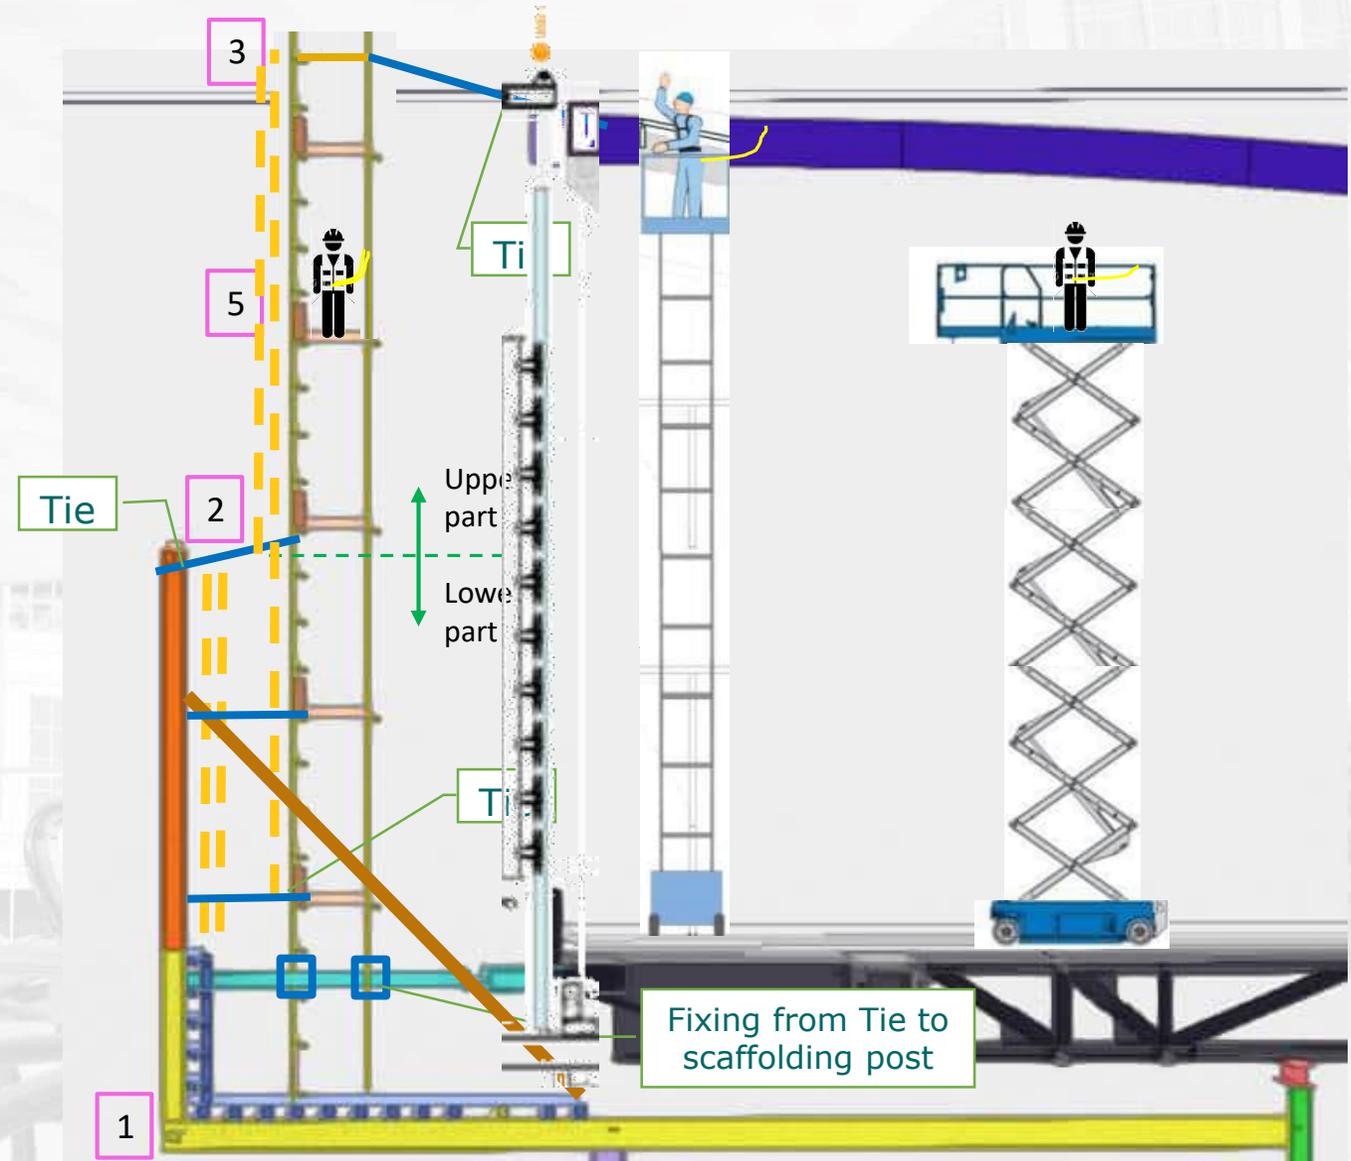
Banquet Hall glass panels Installation

1. Completion of catch fence installation.
2. Install the intermediate ties.
3. Extend the metal scaffold to final level.
4. Install the upper tie (Compensation ties at both sides should be provided when the tie be removed temporarily during seele install glass panel).
5. Erect the scaffolding safety net (double layer).

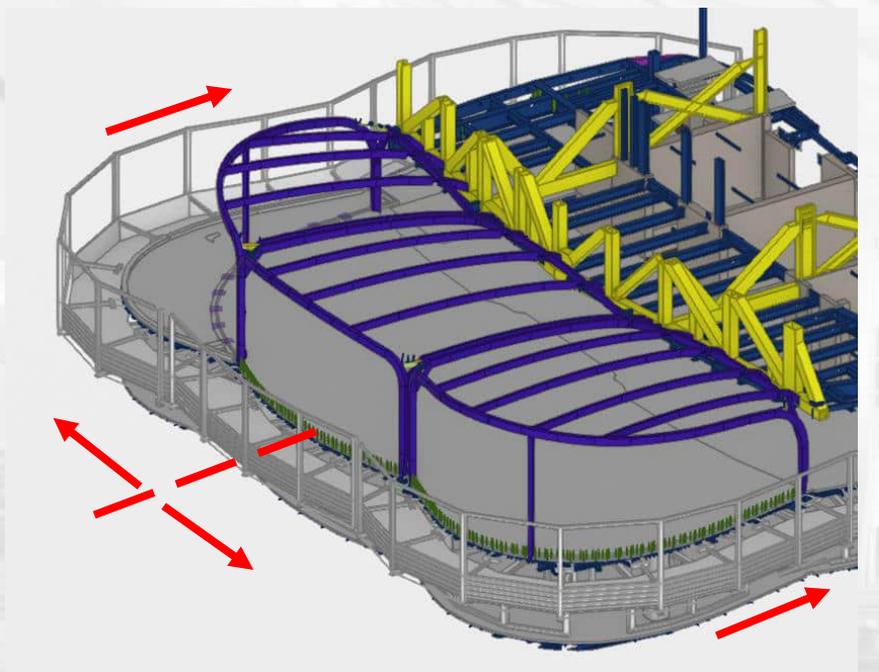
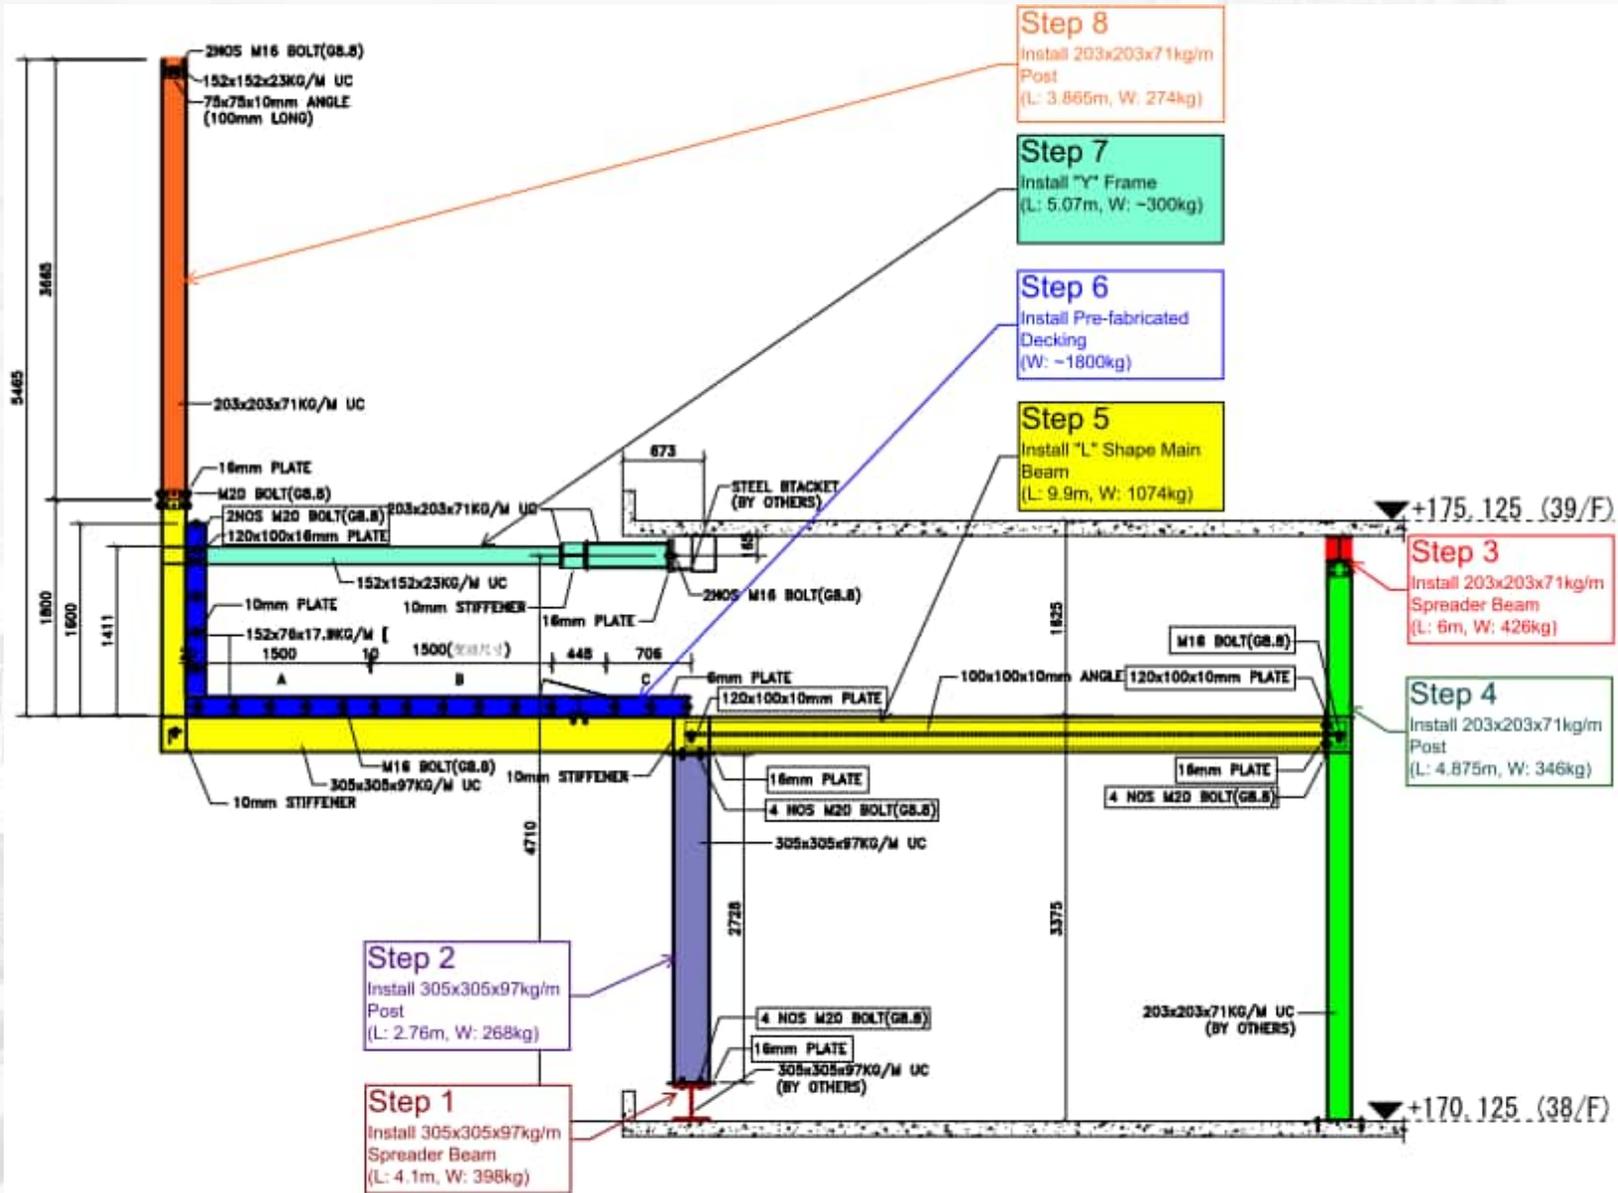
Extensive Catch Fence for Banquet Hall Installation

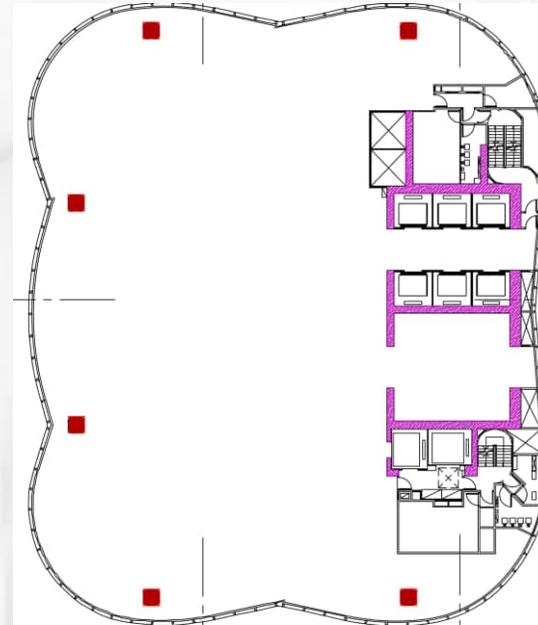
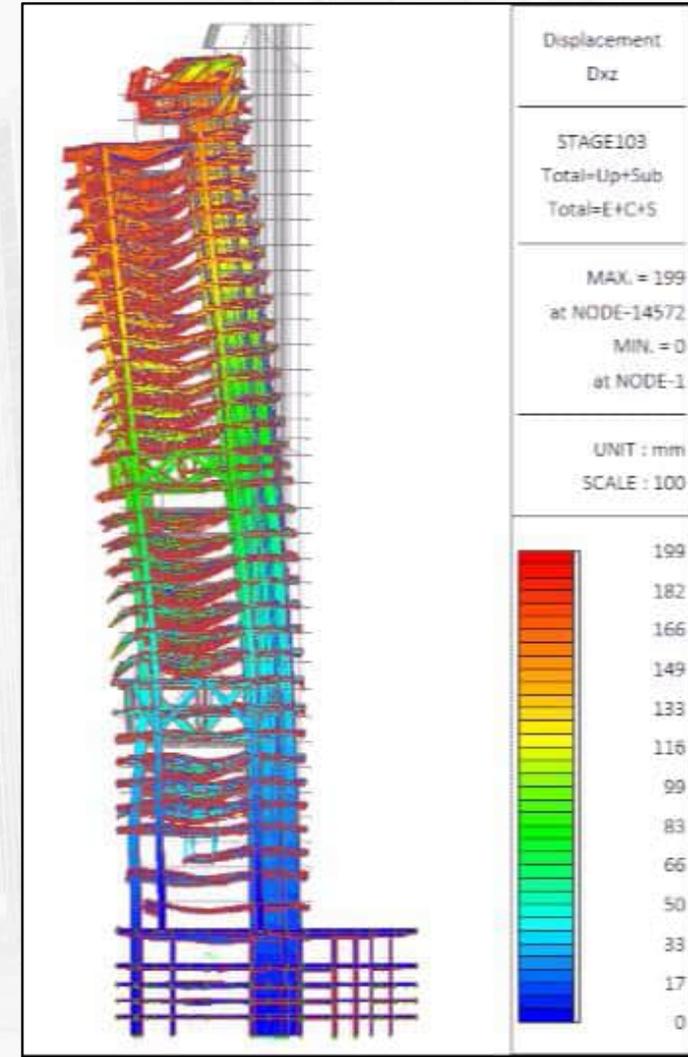
Background of Building Lean

1. Tall building move during construction

- Vertical shortening
- Lateral movement induced by differential shortening

2. Contributing factors

- Time dependent properties of concrete (Creep & Shrinkage)
- Construction sequences
- Structural shape

3. Effects of building movements

- Construction tolerances and serviceability
- Elevators (Passenger comfort)
- Curtain wall / façade (Joint allowance)
