2 Murray Road
(Central)
中環美利道2號

20240525 HKIE Technical Visit (BUD) The Henderson

1. Project Profile

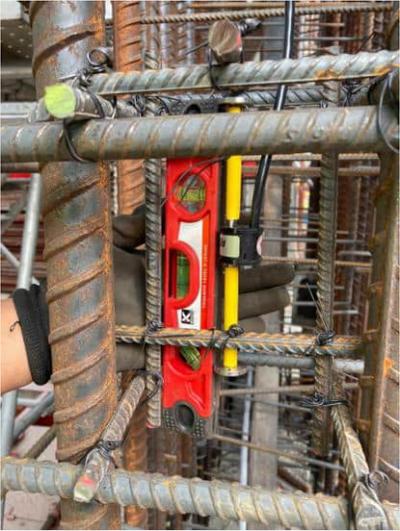
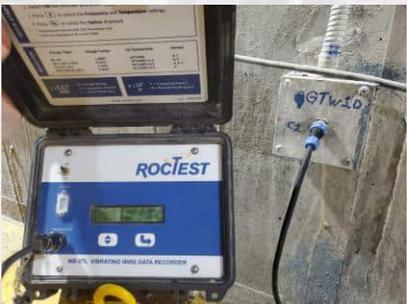
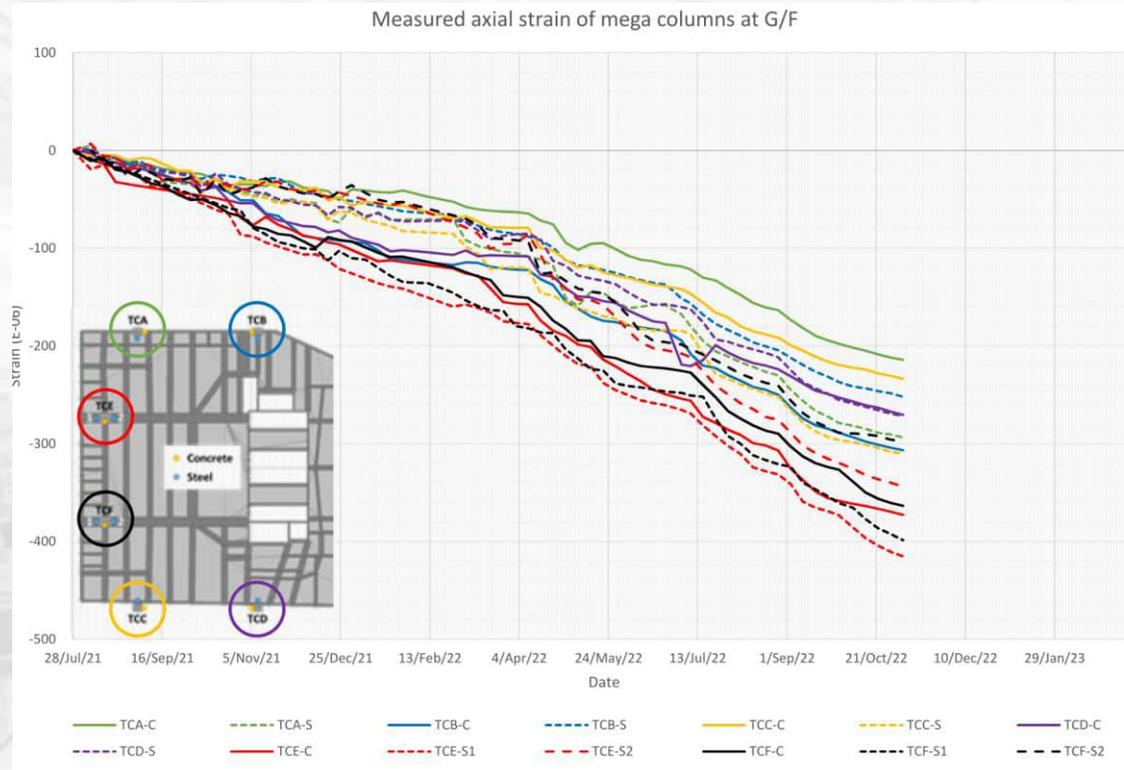
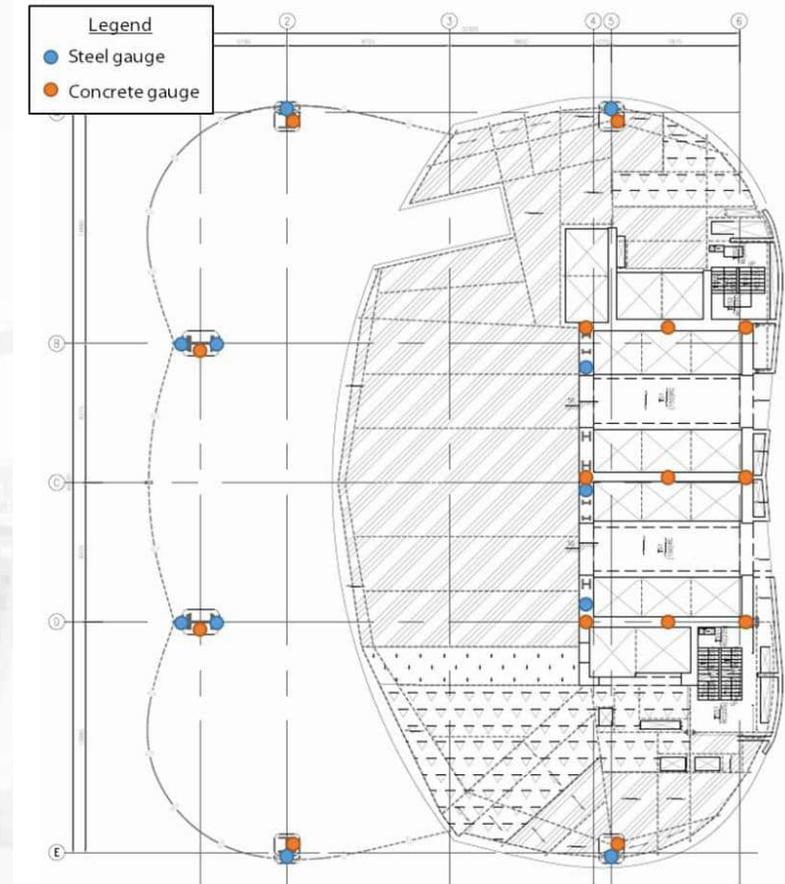
Columns and Core Walls Strain Monitoring

*74 nos of strain gauges embedded in column and core wall
to monitor the change of strain during construction*

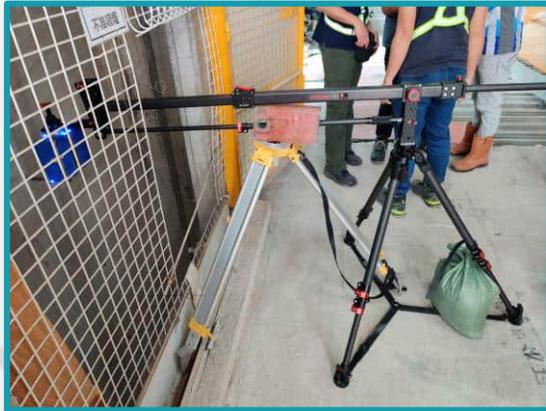
Step 1: Laser Scanner Data Capture

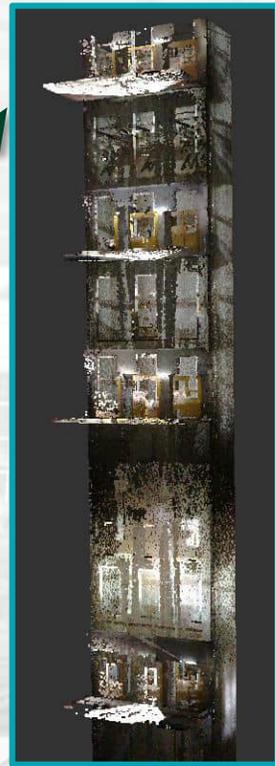
Step 2: Create reality point clouds model

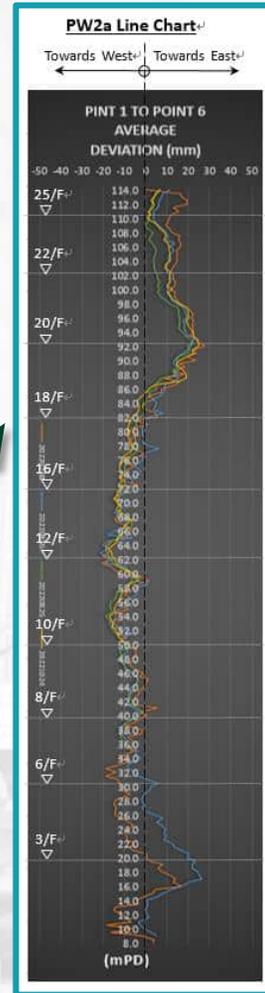
Monthly data import to monitor Elevator Shaft variation

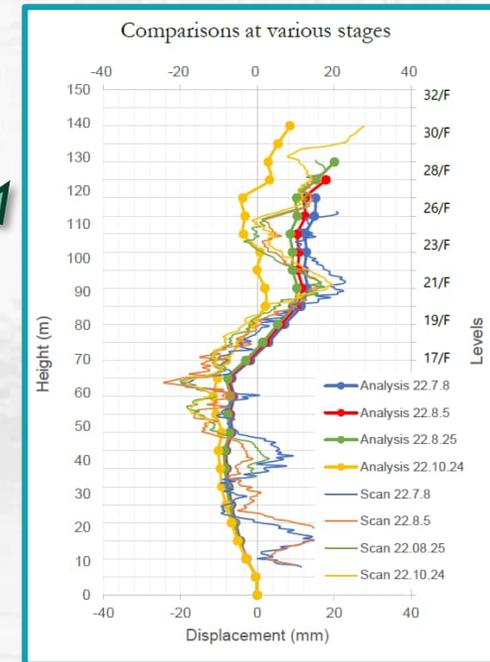
Analysis vs Laser Scan

Synchronize comparison of field survey data with time-dependent analysis results by Advanced Stage Analysis Program (ASAP)

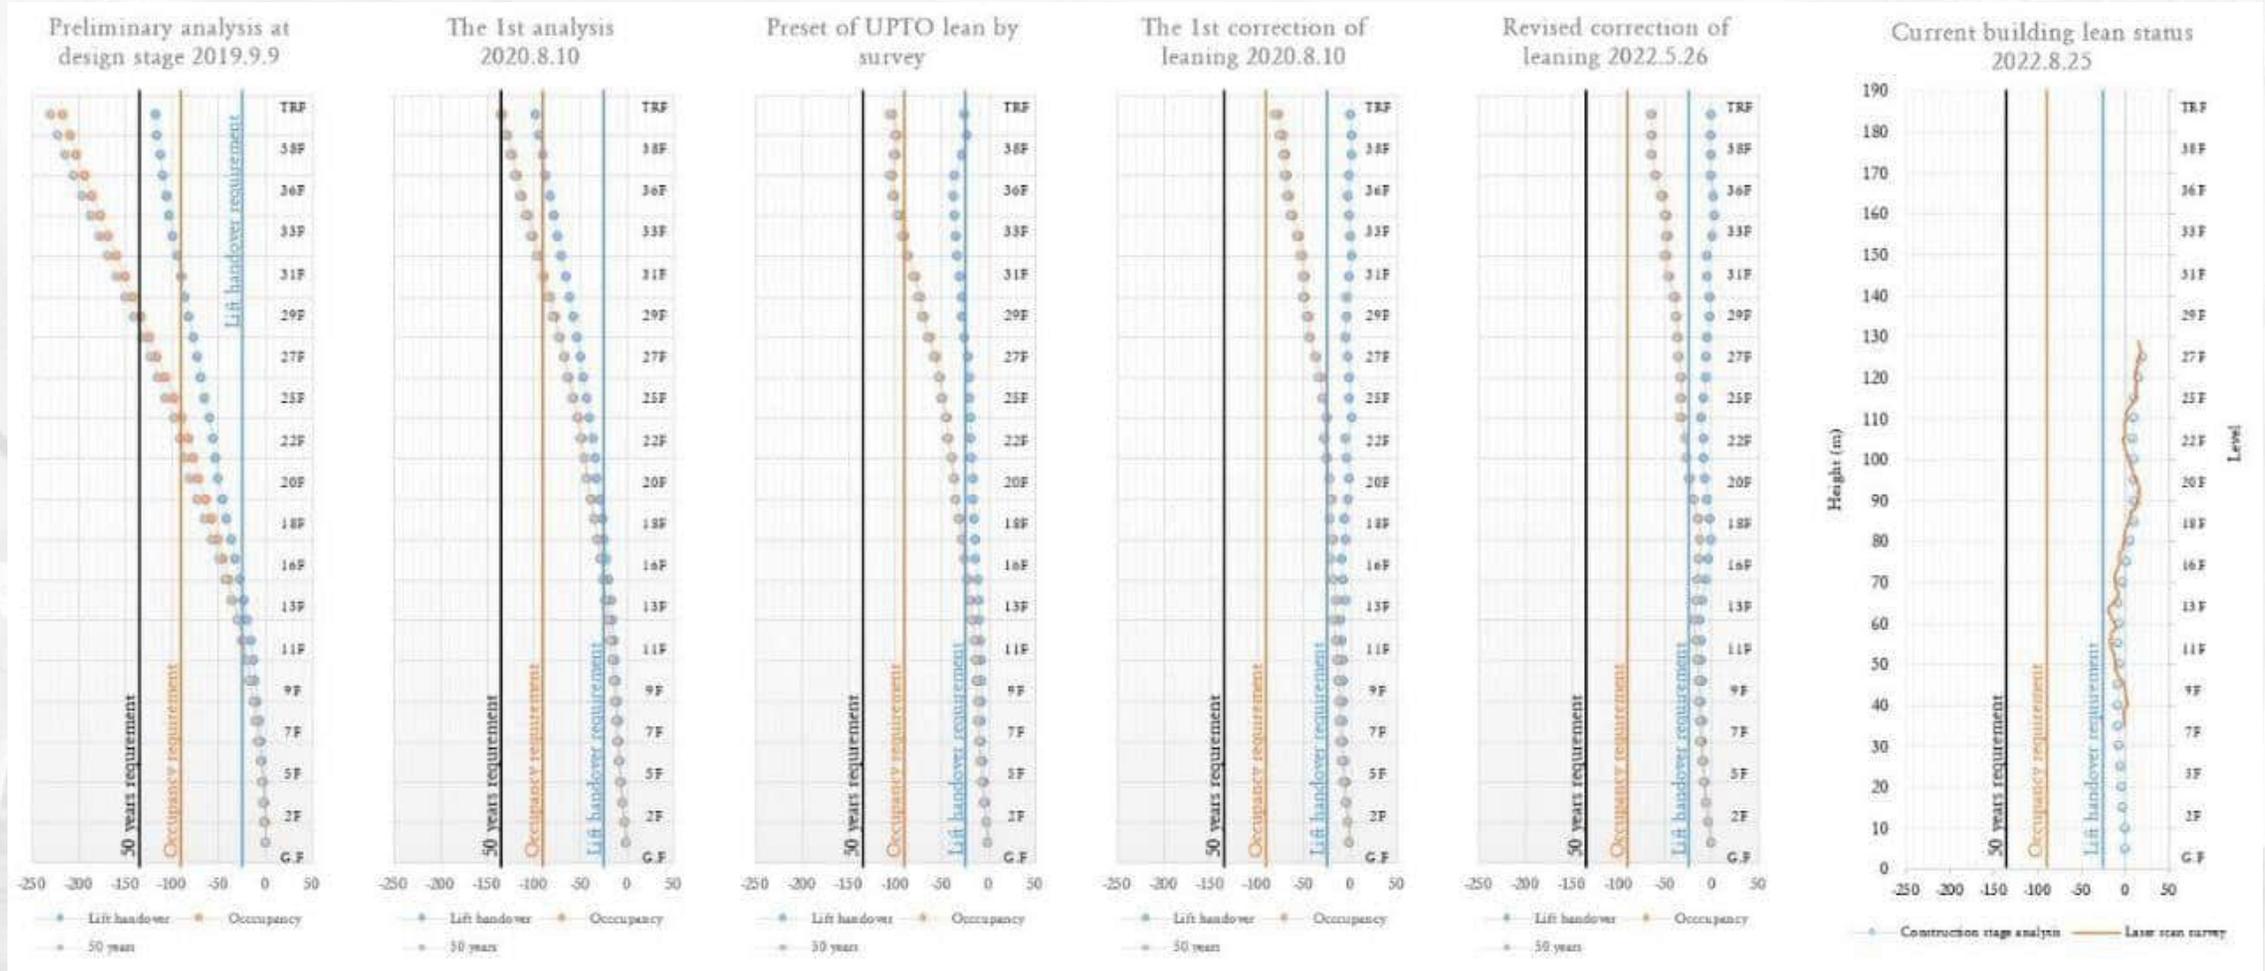
Milestones of building lean 2019~2022

Lift installation = 117mm
Occupancy = 217mm
50 Years = 230mm
(Sept 2019)

Lift installation = 21mm
Occupancy = 63mm
50 Years = 65mm
(May 2022)

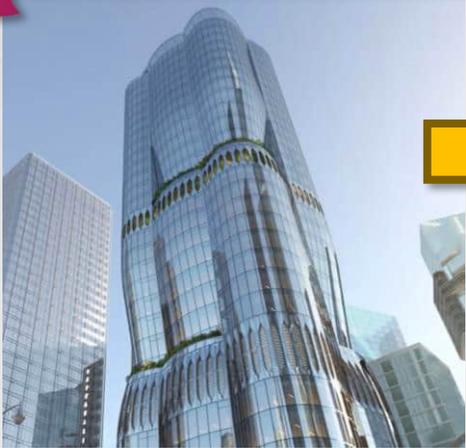
DfMA Extension – Inclined Façade Curbs

Challenge found:
Inclined Curve Curtain Wall

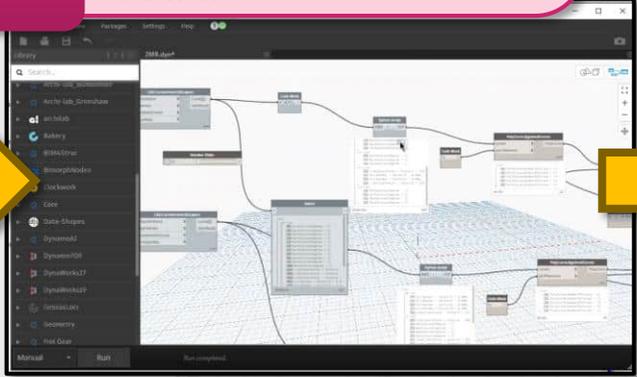
1 Automation to optimize façade element

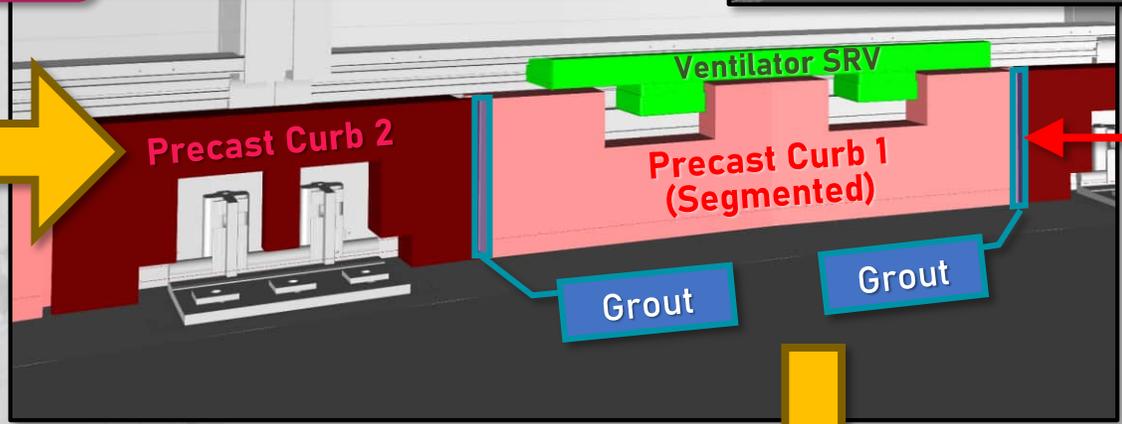
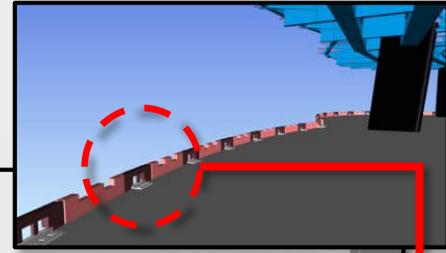
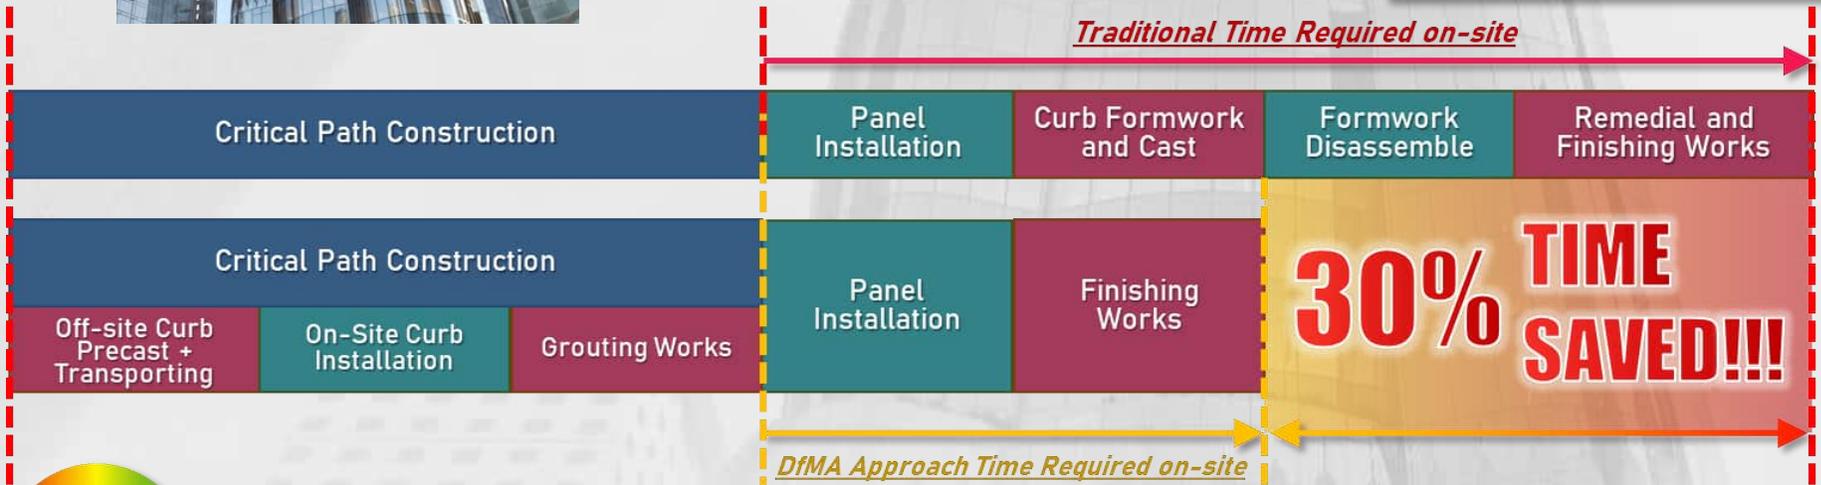
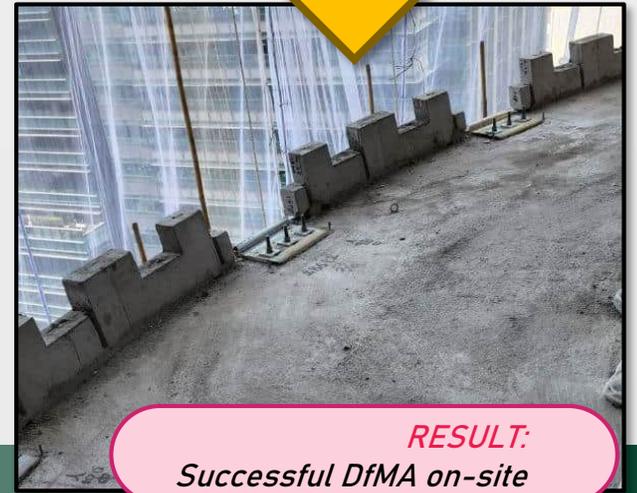
2 Modularize precast façade curb into segments for detail coordination

RESULT:
Successful DfMA on-site

>Over 70% façade curb modularized

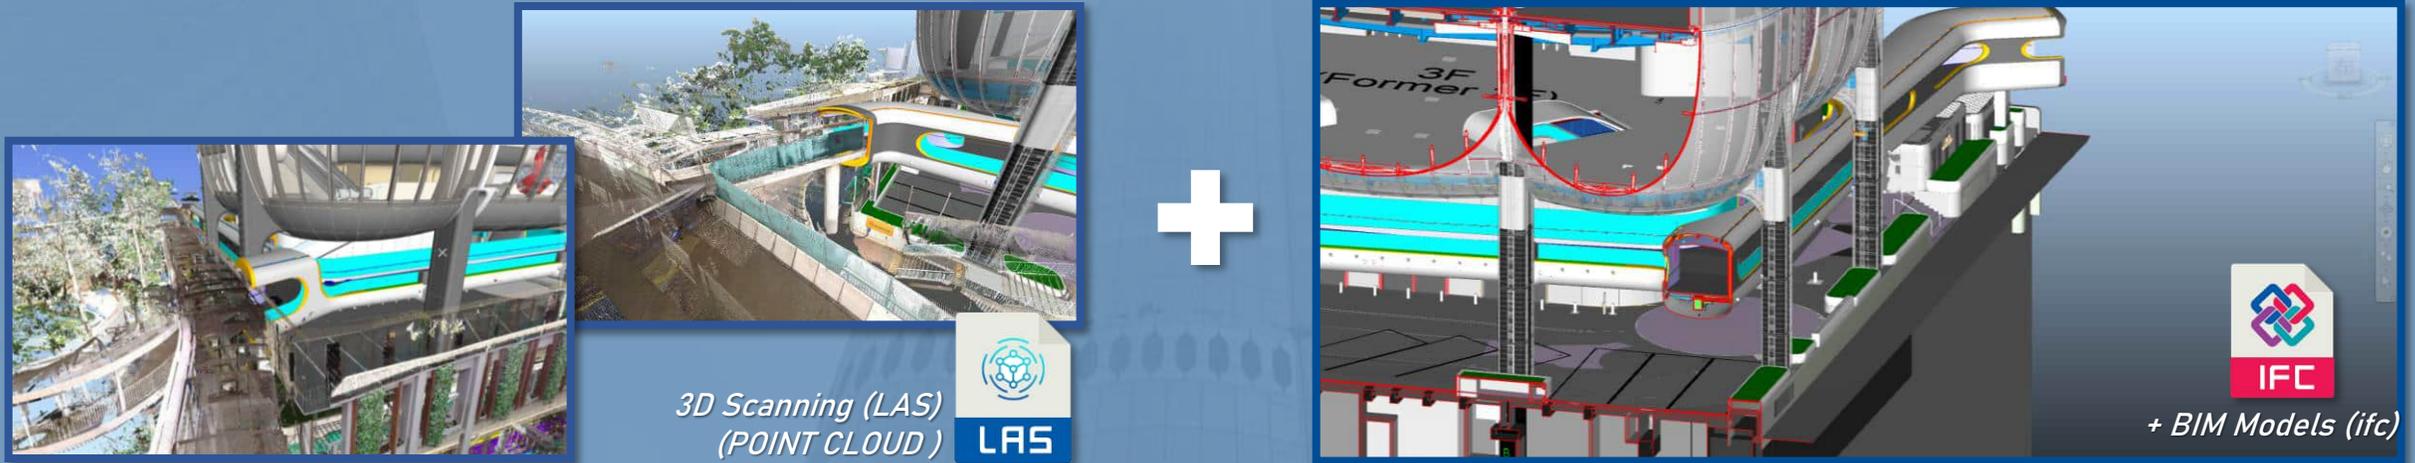
We use **3D scanning/point cloud** to check the relationship between the new **footbridge** and the existing footbridge. 3D scanning provide an as-built 3D model geometry of existing building elements, allowing construction team to visualize the **full picture in current**. The use of 3D scanning over traditional hand measuring methods vastly improves the accuracy of the final BIM model which also greatly **benefits Visual Design and Construction (VDC)**.

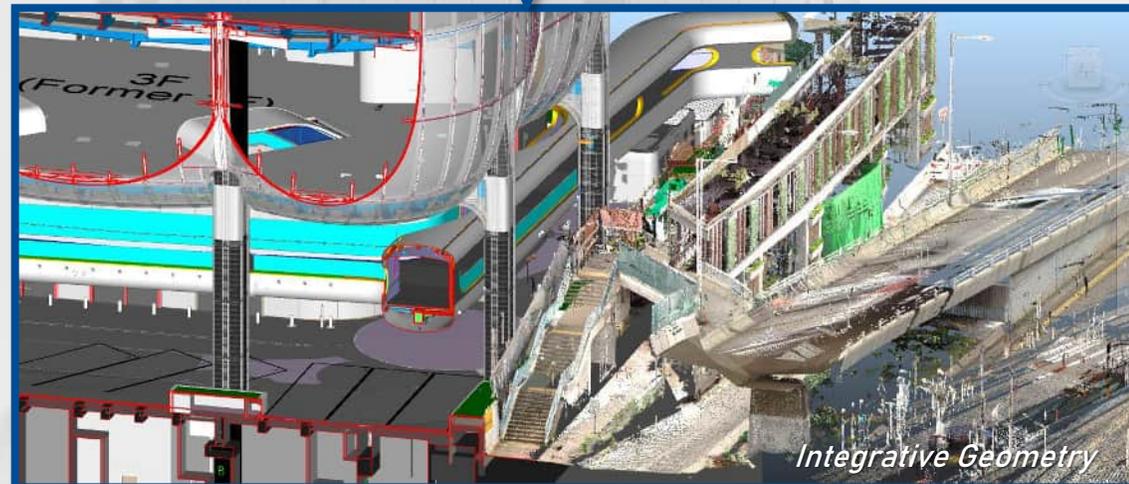
Result

- ✓ **Better** decision-making
- ✓ **Accelerated** risk assessment
- ✓ **Predictive** construction
- ✓ **Cross-platform** interoperability for coordination

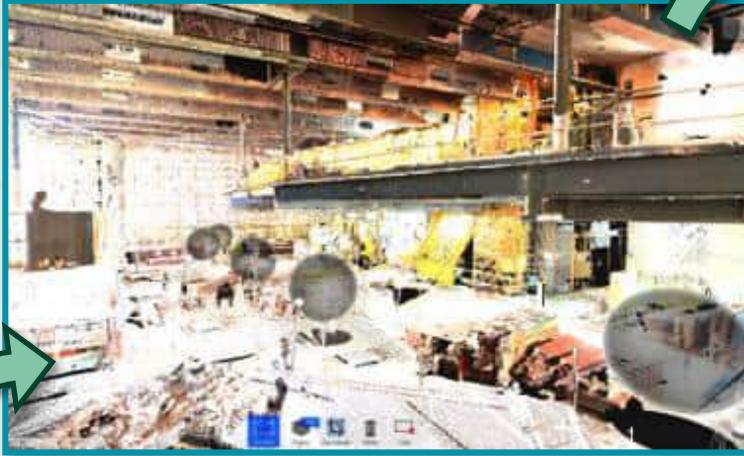
Step 2: Register reality point clouds into .las

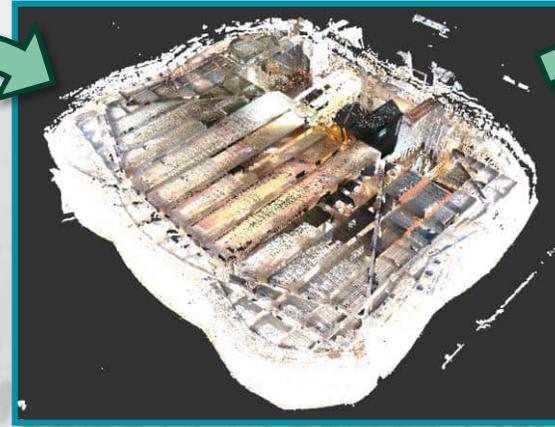
Step 3: Integrate point clouds with IFC models to compare precision

Data analysis and report generated by Point-cloud based Verification Software (Verify construction tolerance & MEP clearance!)

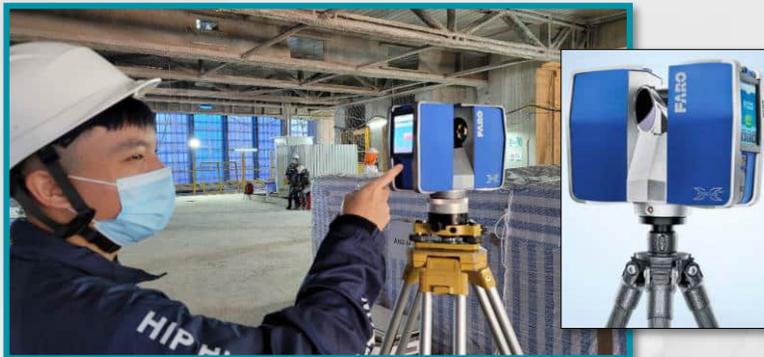
Step 1: Scan steel structure for precision verification

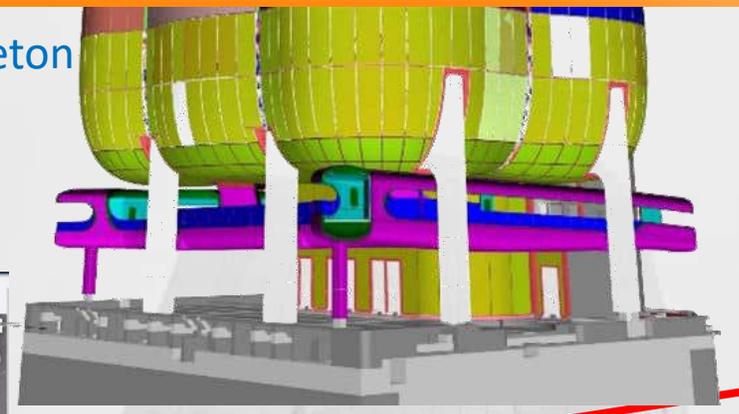
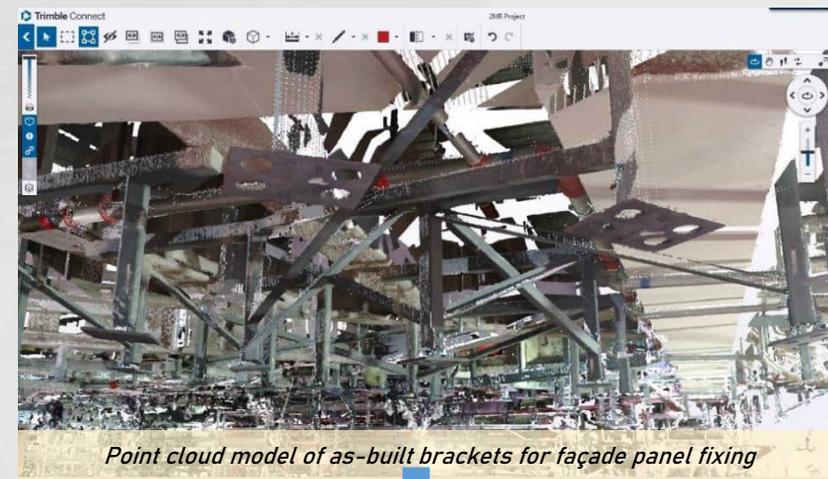
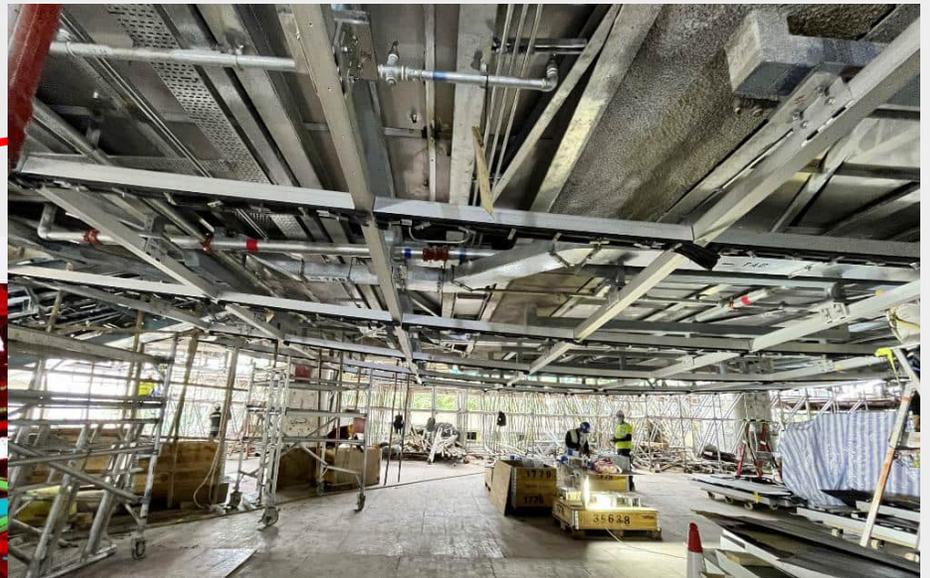
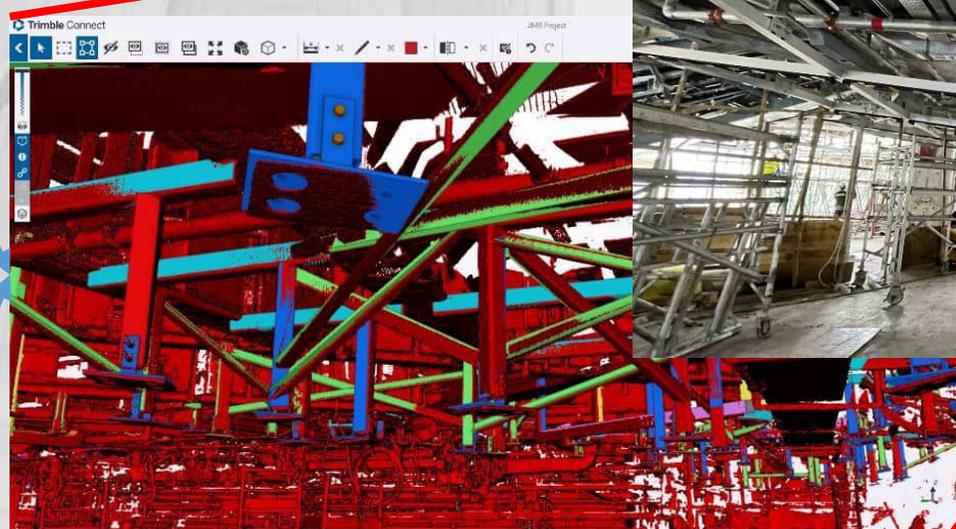
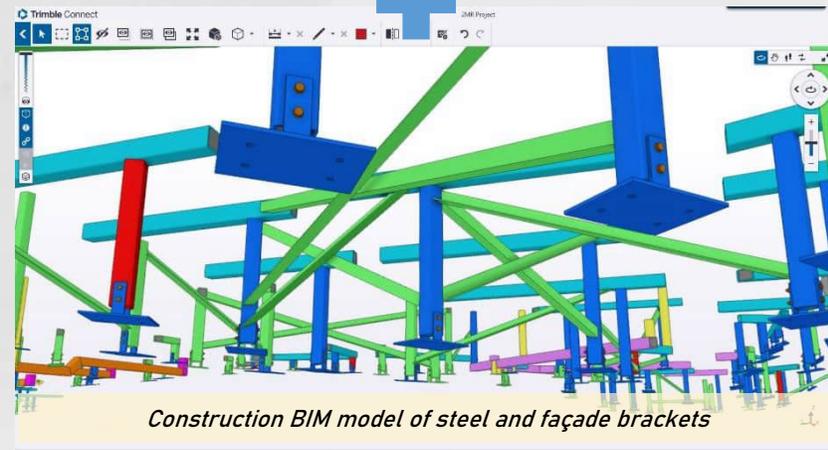
Adopt 3D Scan to Check the As-Built Skeleton

Clear overlay of as-built point cloud with BIM model, for risk identification before irremediable façade fixing problem occurs.

- 1. Over 95% steel effectively scanned within 1 Day for each floor
- 2. Smooth processing with IFC: Deviation report generated in 1 Day (after point cloud registration in .las)

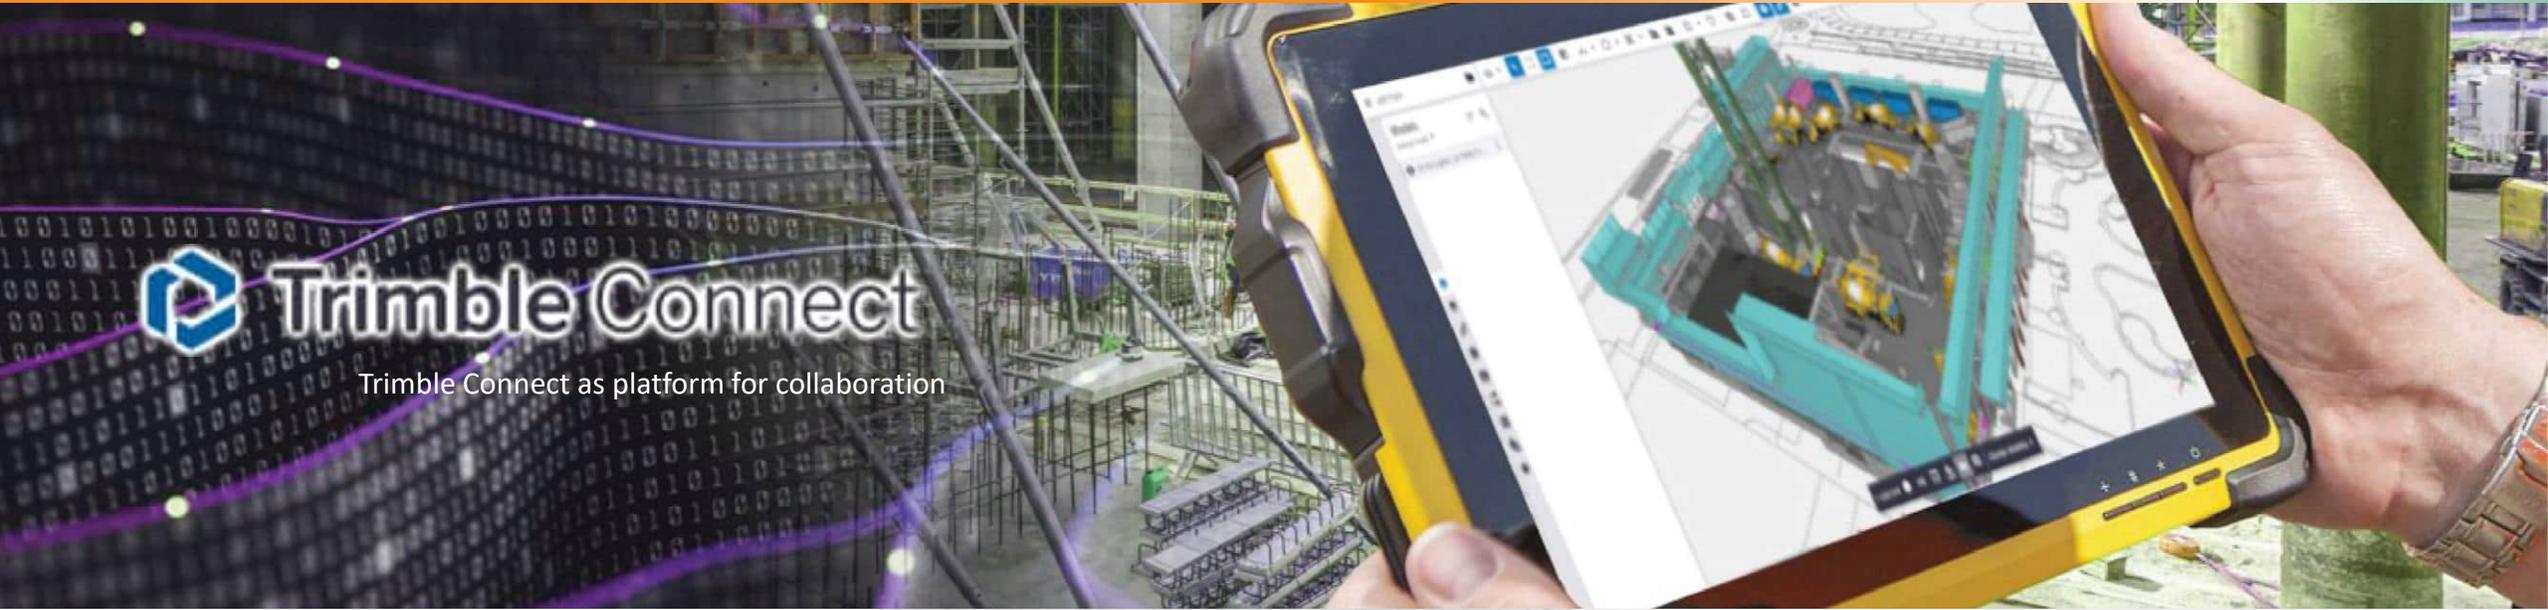
During construction stage, all major appointed parties are requested to equip CDE skills to resolve clashes and develop model in at the constructible level of detail.

Online CDE facilitates real-time information exchange like design comment, project issues sharing and information model exchange without geographical limit.

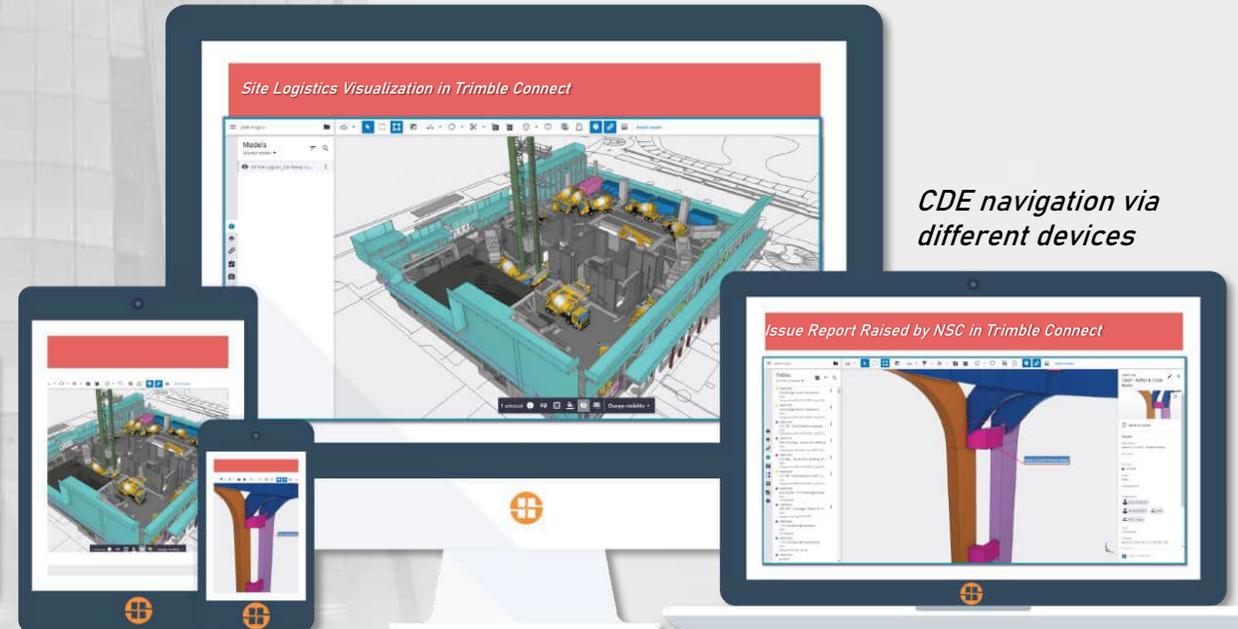
CDE navigation via different devices

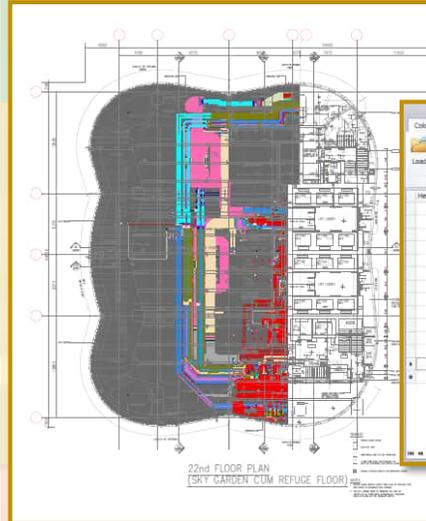
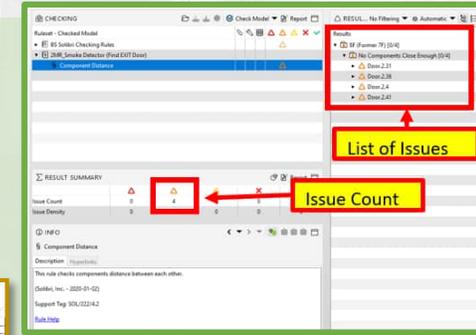
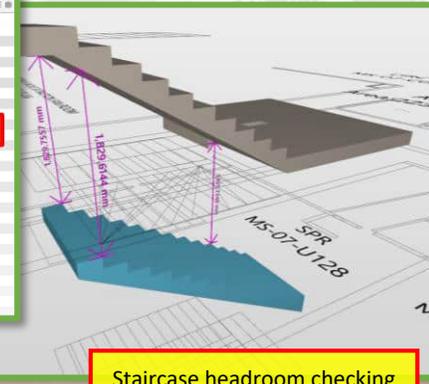
Automation 1: Rule-based checking against building ordinances (Solibri)

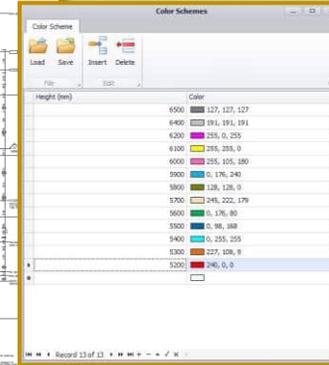
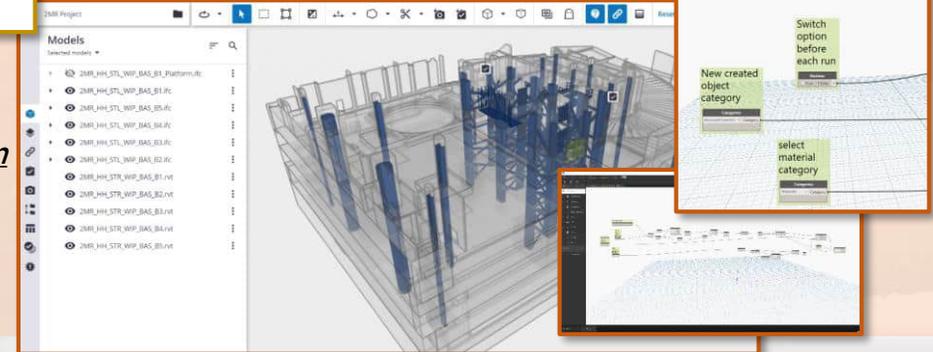
Automation 2: MEP achievable headroom demarcation (Co-developed programme)

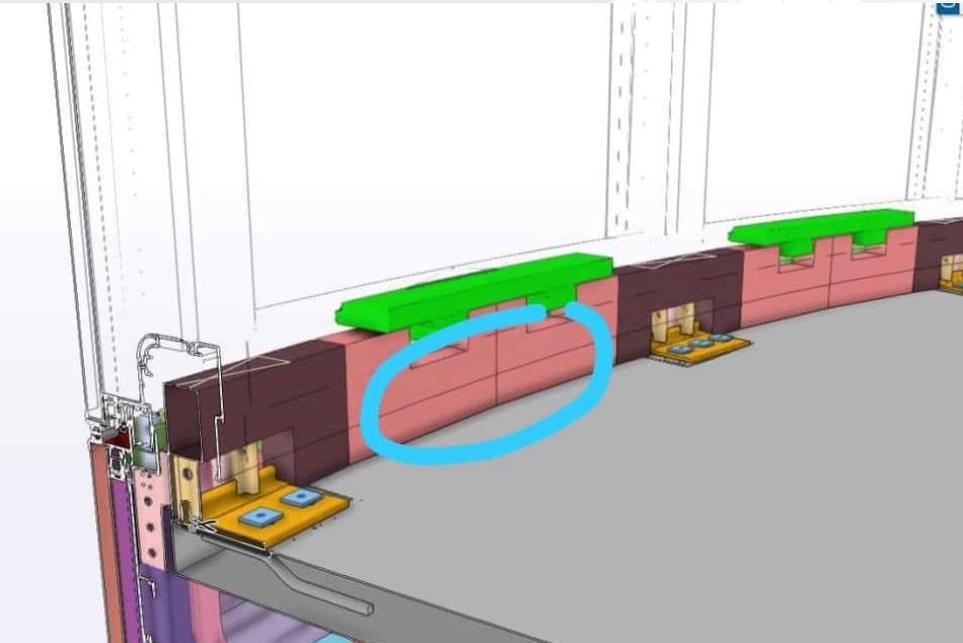
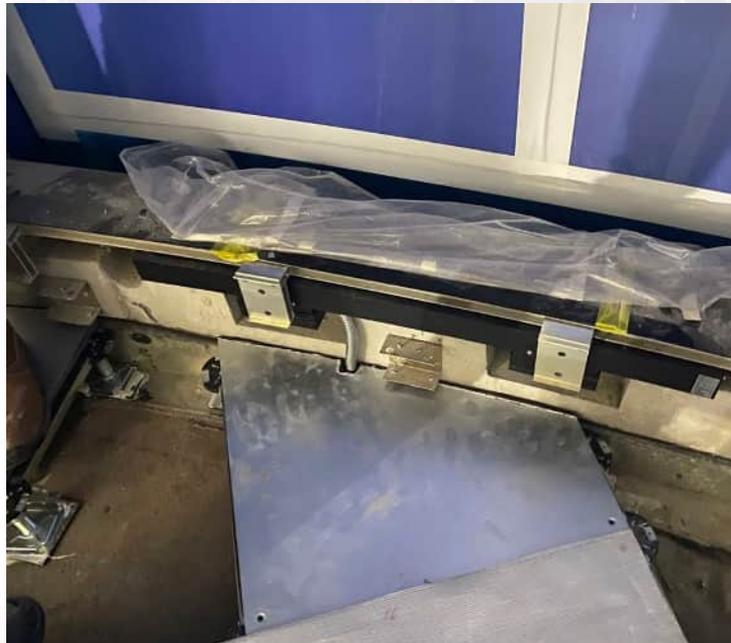
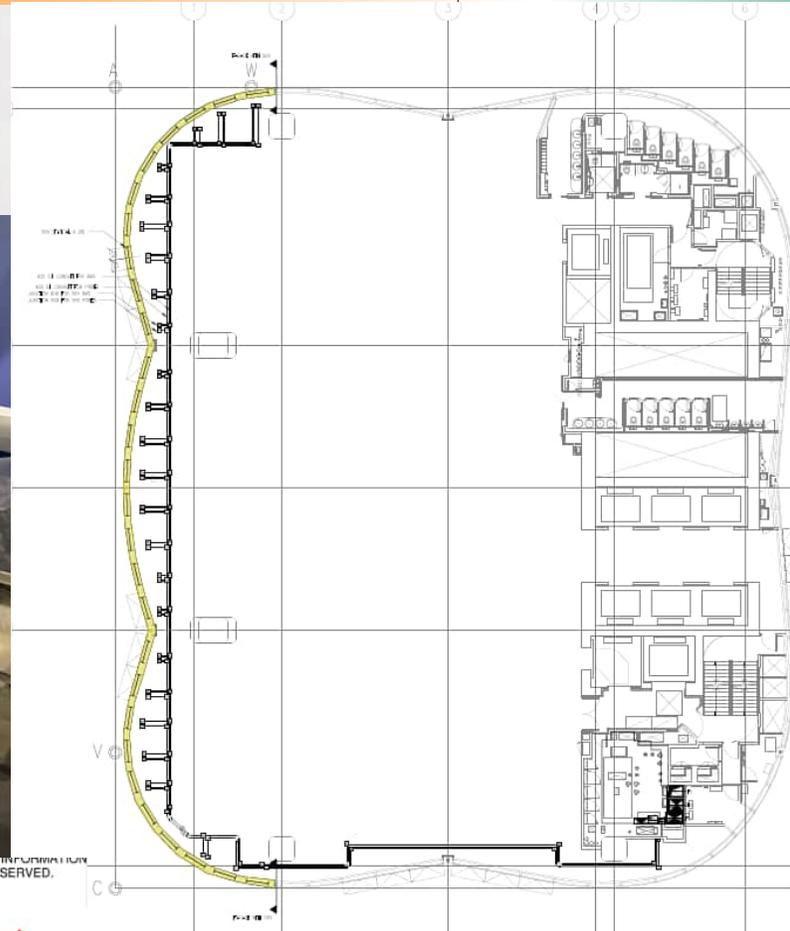
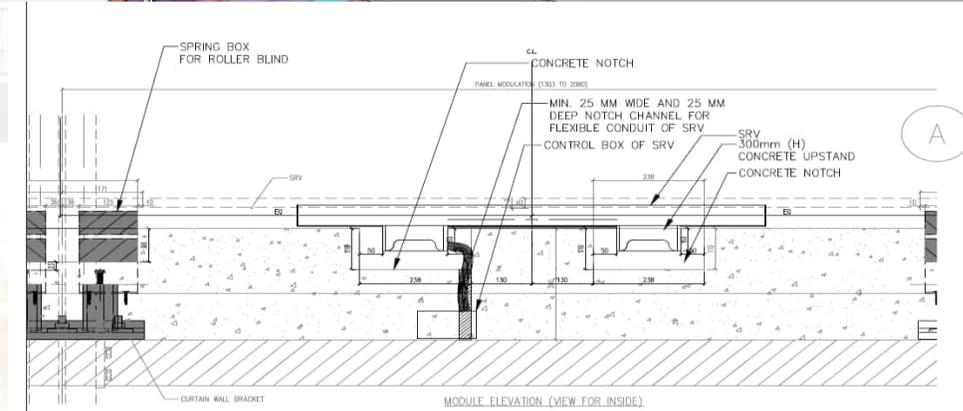
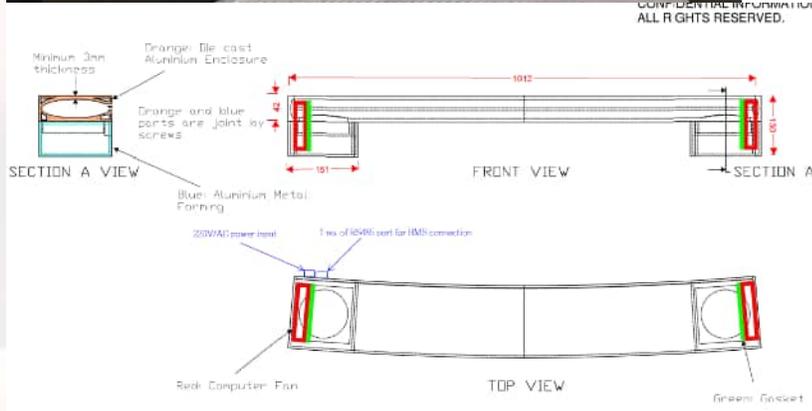
Solar Responsive Ventilator (SRV)

- Aims to enhance indoor thermal comfort along west perimeter zone
- Slow air speed ventilator with 2nos DC fans covered by metal box

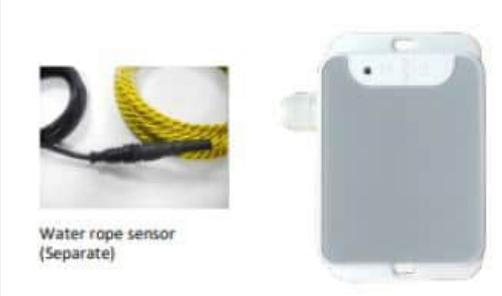
IOT Sensor Type	Photo	IOT Sensor Type	Photo
<p>Water Leakage Sensor (sensing cable type)</p>

IOT Sensor Type
Water Leakage Sensor (sensing cable type)

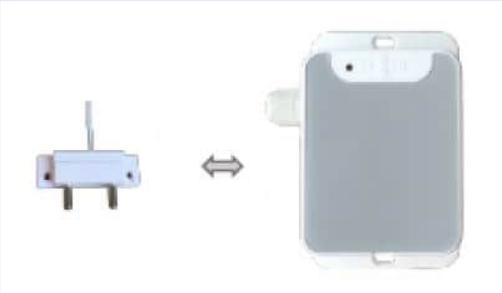
<p>Water Leakage Sensor (point type)</p>

Water Leakage Sensor (point type)

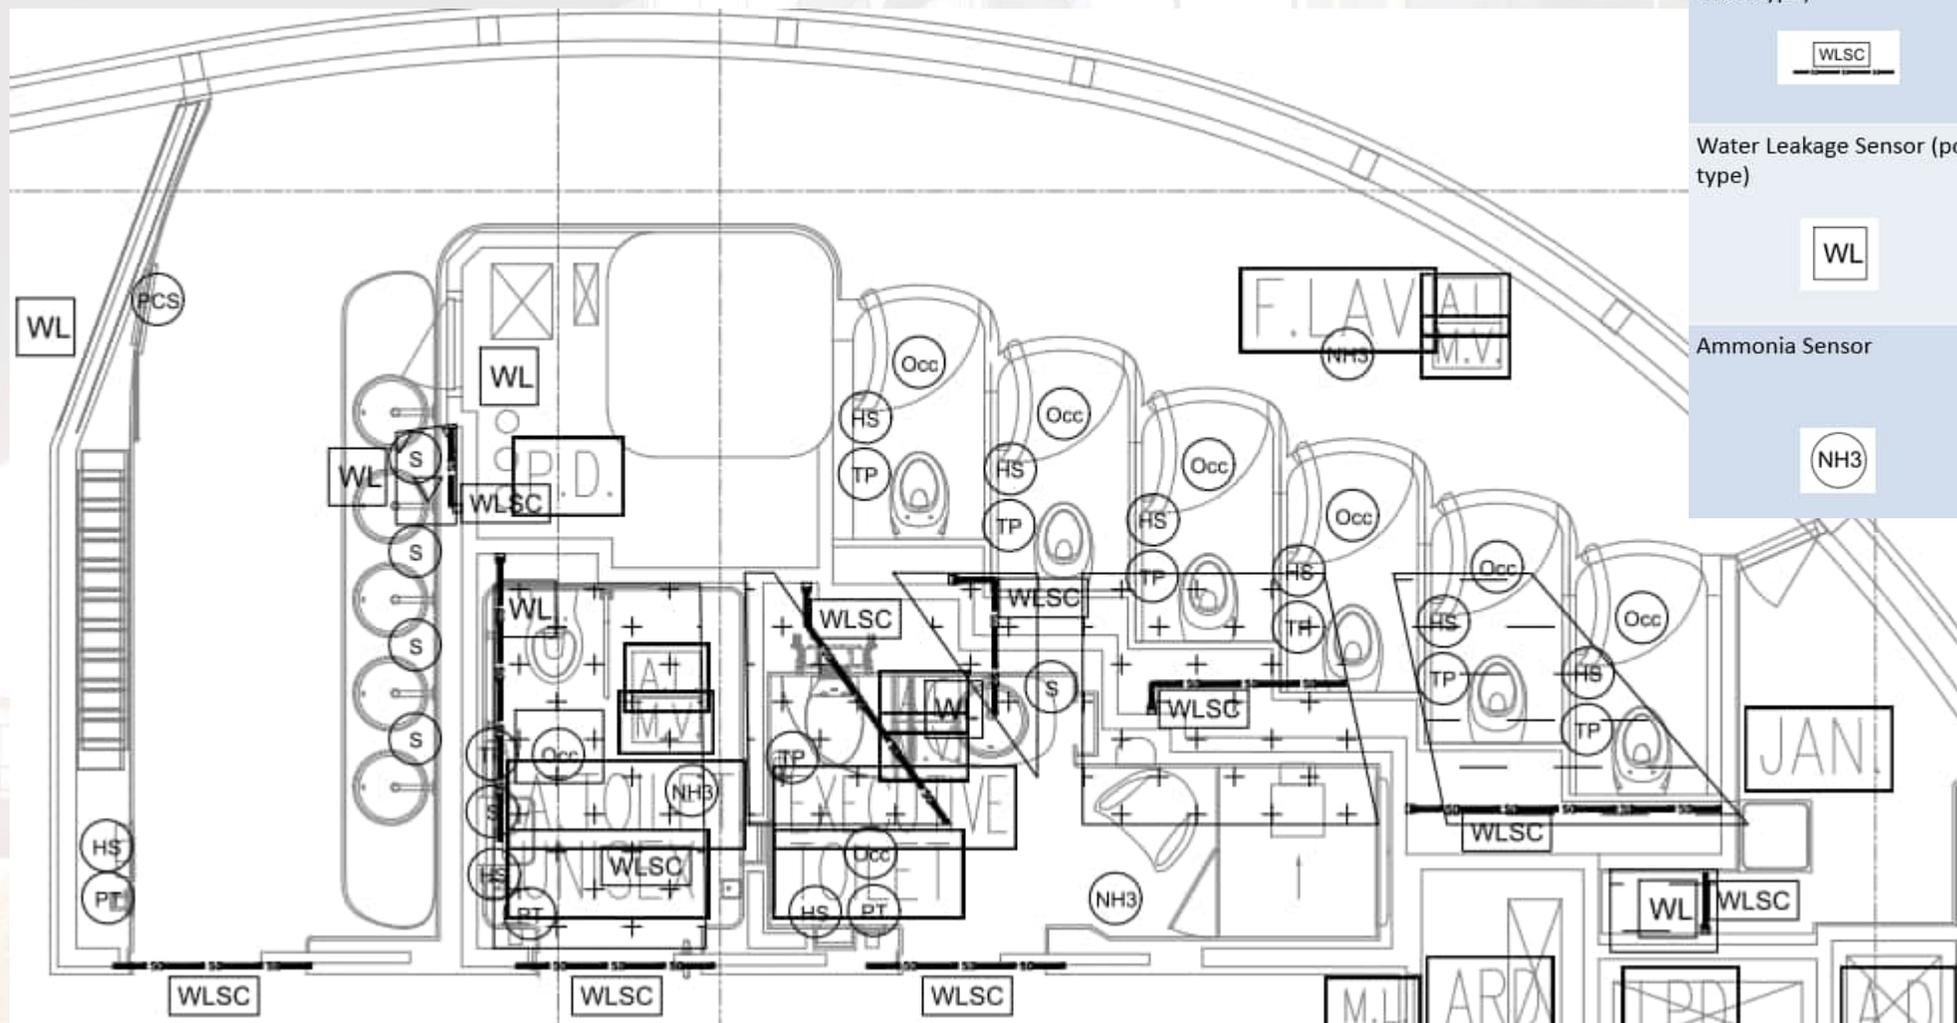
Example of Location of using IOT Sensor: Toilet Area
